17 AUGUST 2021

Introduction

[1] A G is the owner of a residential property at XXXX , Christchurch. He has owned the property since 1994.

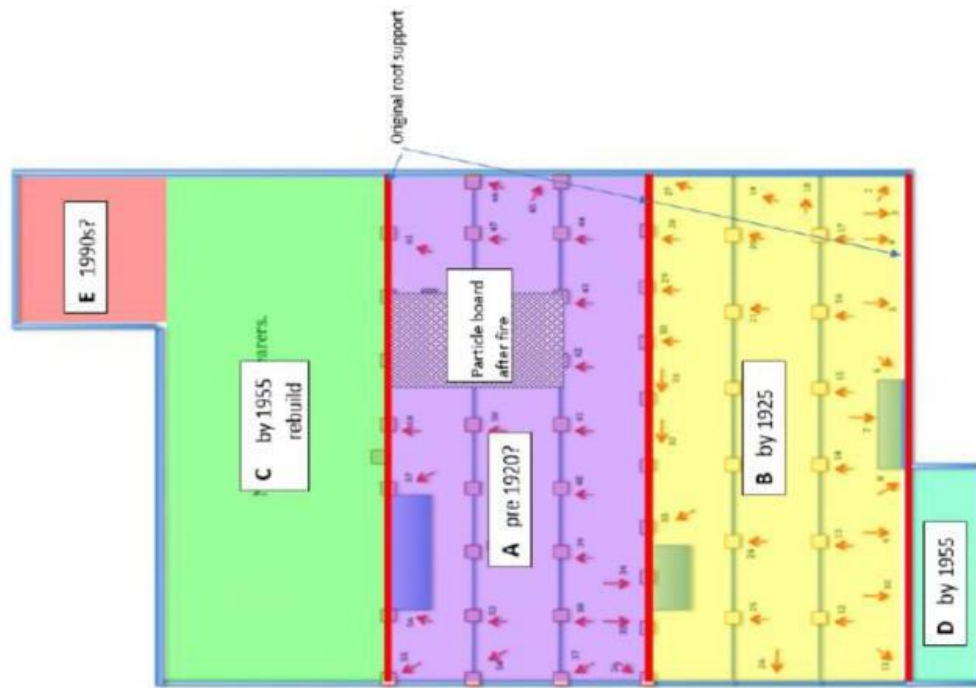
[64] Ms Halliday's Technical Advice Document provided a plan outlining the historical extensions to the property as follows:

- (a) "Each major addition locked in the existing deformations. This is evidenced by the lack of packing in the foundations, and common practice...It is not likely that the whole of this house has been level since it was first constructed 100 years ago."

- (b) "Foundations will go down wherever the loads are higher. The original roofs put loads in different places (red lines) to the re-roof by 1955 which moved the loads to the blue lines. The foundation movement is consistent with the history of the load and with locations that have had water problems."

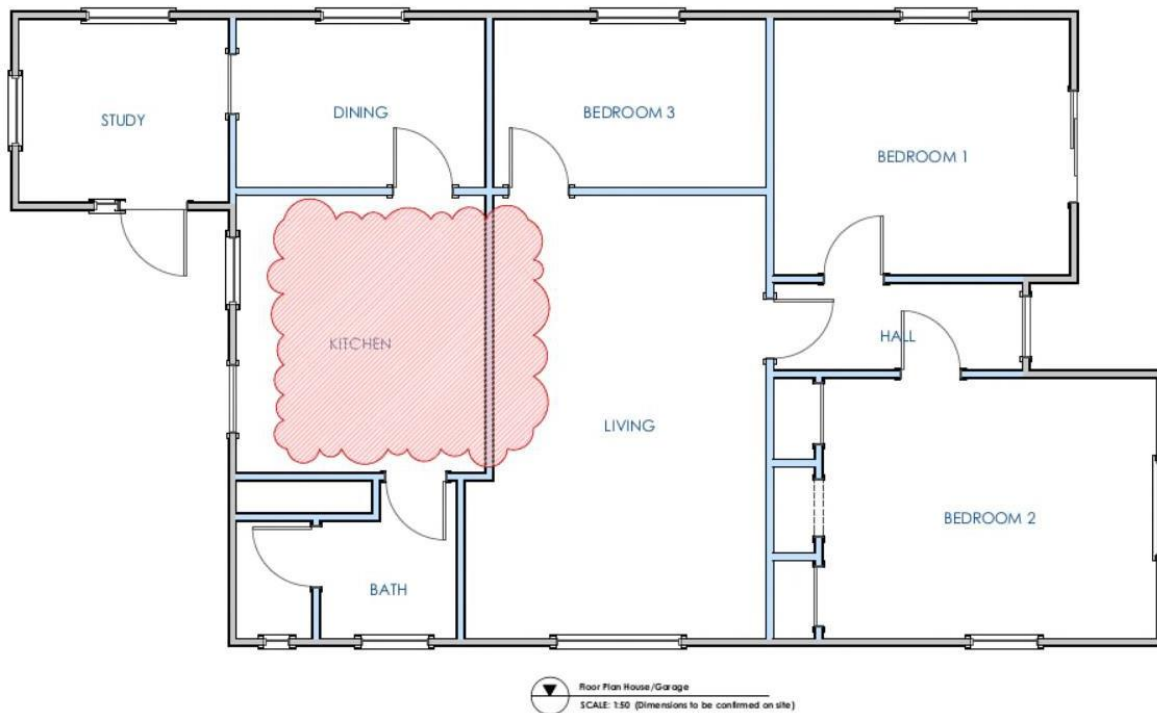
[112] So, the existence of dislevelment in the benchtops and sticking of doors in the kitchen cabinetry following the earthquakes is persuasive evidence of damage. The Tribunal finds that the kitchen floor has dropped as a result of earthquake damage to the foundations in that area.

[113] Mr Day identified the area as follows:

[114] The Tribunal finds that the earthquakes caused damage to the kitchen which included damage to the foundations in that area, together with associated damage to flooring, wall coverings and the dislevelment of the kitchen benches and cabinetry.

[115] The debate then turns to what is required to remediate that damage. The Tribunal heard from Mr G's expert, Mr Kearney and his builder, Mr Paltridge, about what was required to remediate this damage. That approach was to a large extent predicated on there being a finding that the entire foundations of the house were to be rebuilt. They did not consider that localised releveling was possible.

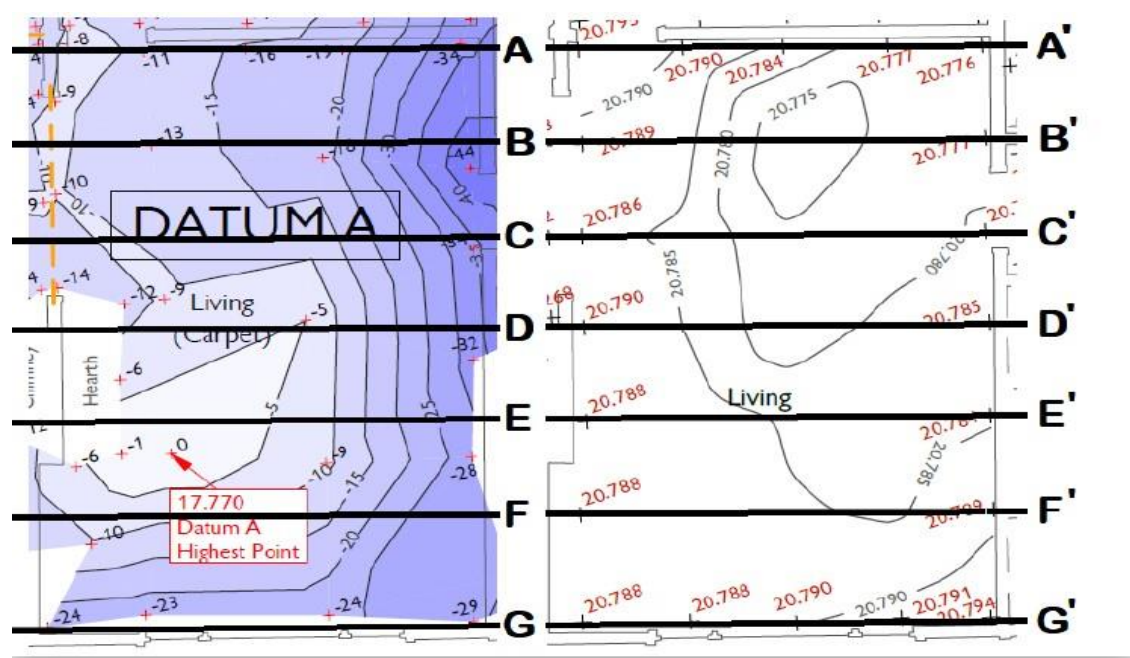
Figure 1 - Sections through the living room in the east-west direction
(floor levels on the left, ceiling levels on the right)

[162] The ceiling levels and whether they followed the floor levels or were inconsistent with the ceiling levels were an issue as to whether there was earthquake damage in the living room.

Section Line	Floor slope and direction	Section Line	Ceiling slope and direction
A	26mm to the east	A'	17mm to the east
B	34mm to the east	B'	12mm to the east
C	23mm to the east	C'	5mm to the east
D	22mm to the east	D'	5mm to the east
E	21mm to the east	E'	4mm to the east
F	17mm to the east	F'	1mm to the west
G	5mm to the east	G'	6mm to the west

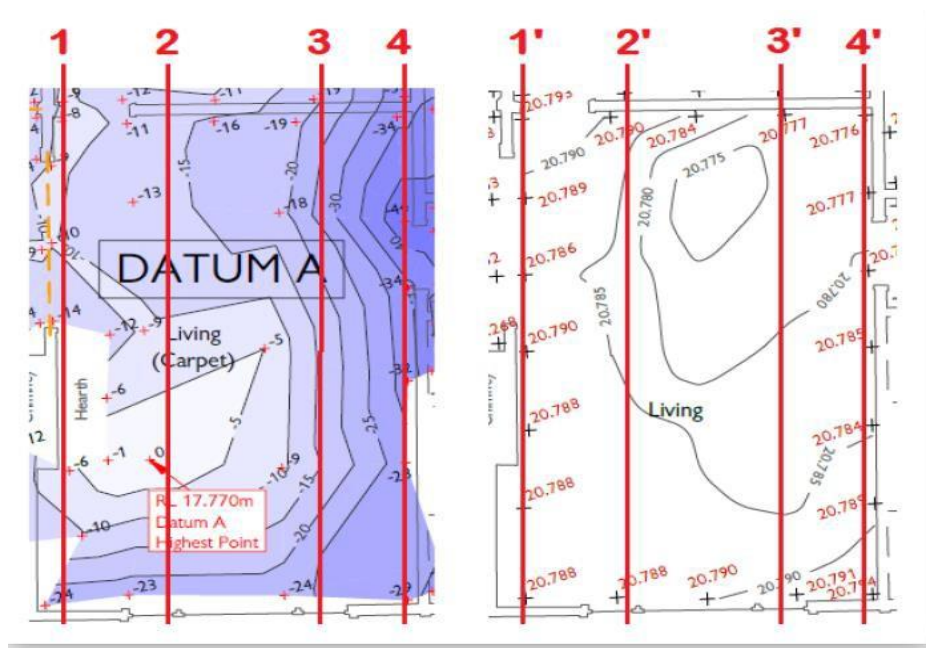
Figure 2 - Sections through the living room in the north-south direction
(floor levels on the left, ceiling levels on the right)

[165] The correlation between ceiling levels and floors in the N-S direction are:
