IN THE MATTER OF CANTERBURY EARTHQUAKES INSURANCE TRIBUNAL
ACT 2019

DECISION # 2 OF C P SOMERVILLE
[Defects and Their Causes]

Dated: 4 December 2020

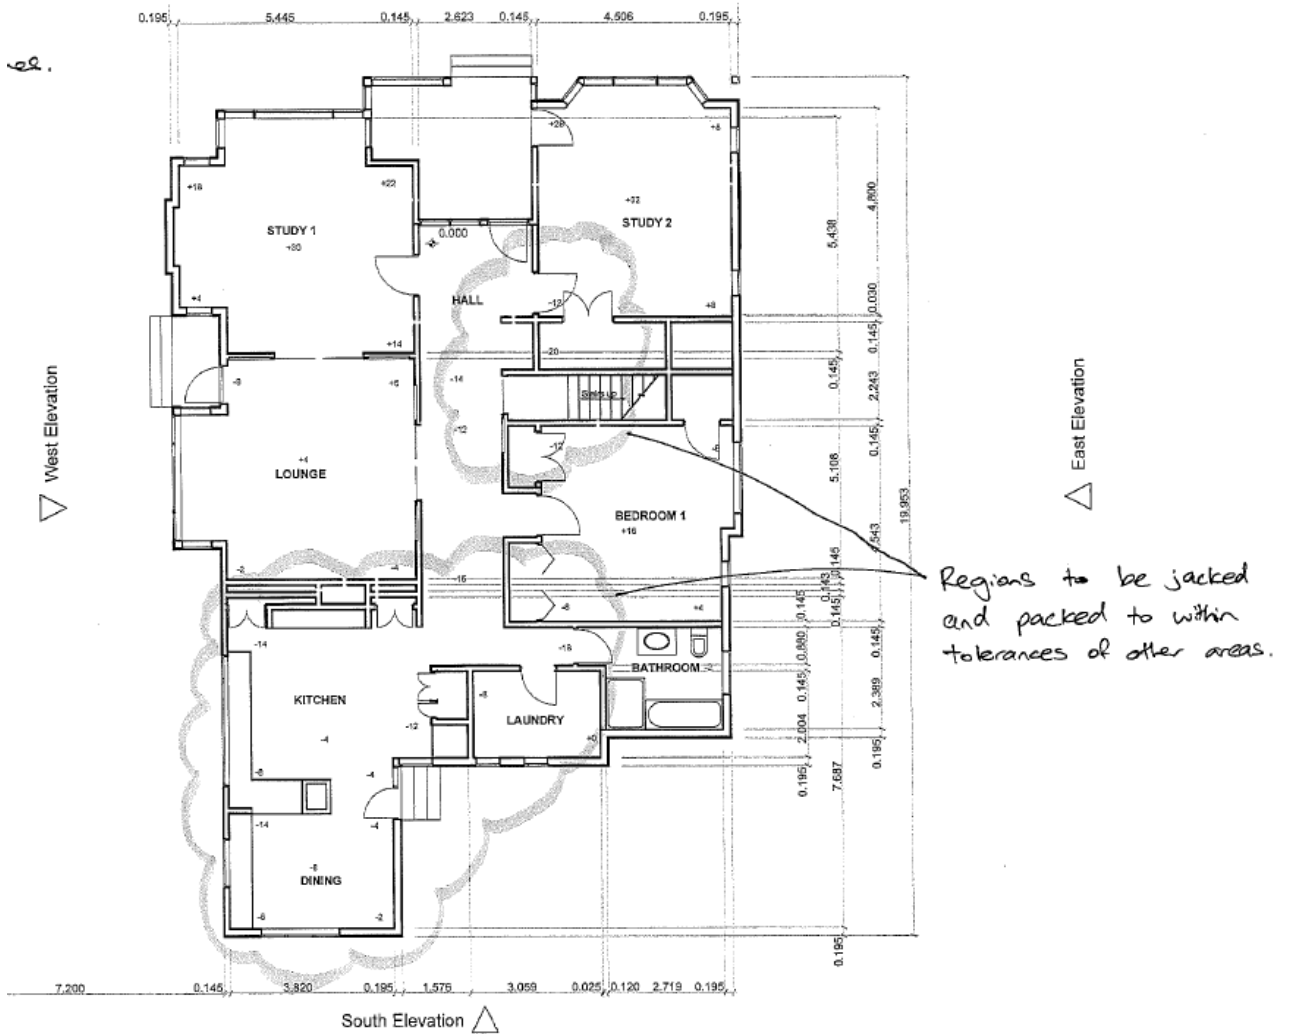
Figure 1: MSC floor level plan

[37] Once IAG accepted liability under the policy, it instructed MSC Consulting Group Ltd (MSC) to carry out a floor level survey which revealed that floor gradients exceeding 1:200 (0.5%) were formed when the front of the house, including the two studies, settled around the perimeter at the same time as the central piles under the studies punched up, causing large gradients to form. The remainder of the house appeared to have a general slope down towards the rear. MSC's floor level plan can be found in Appendix 1 as Figure 1.

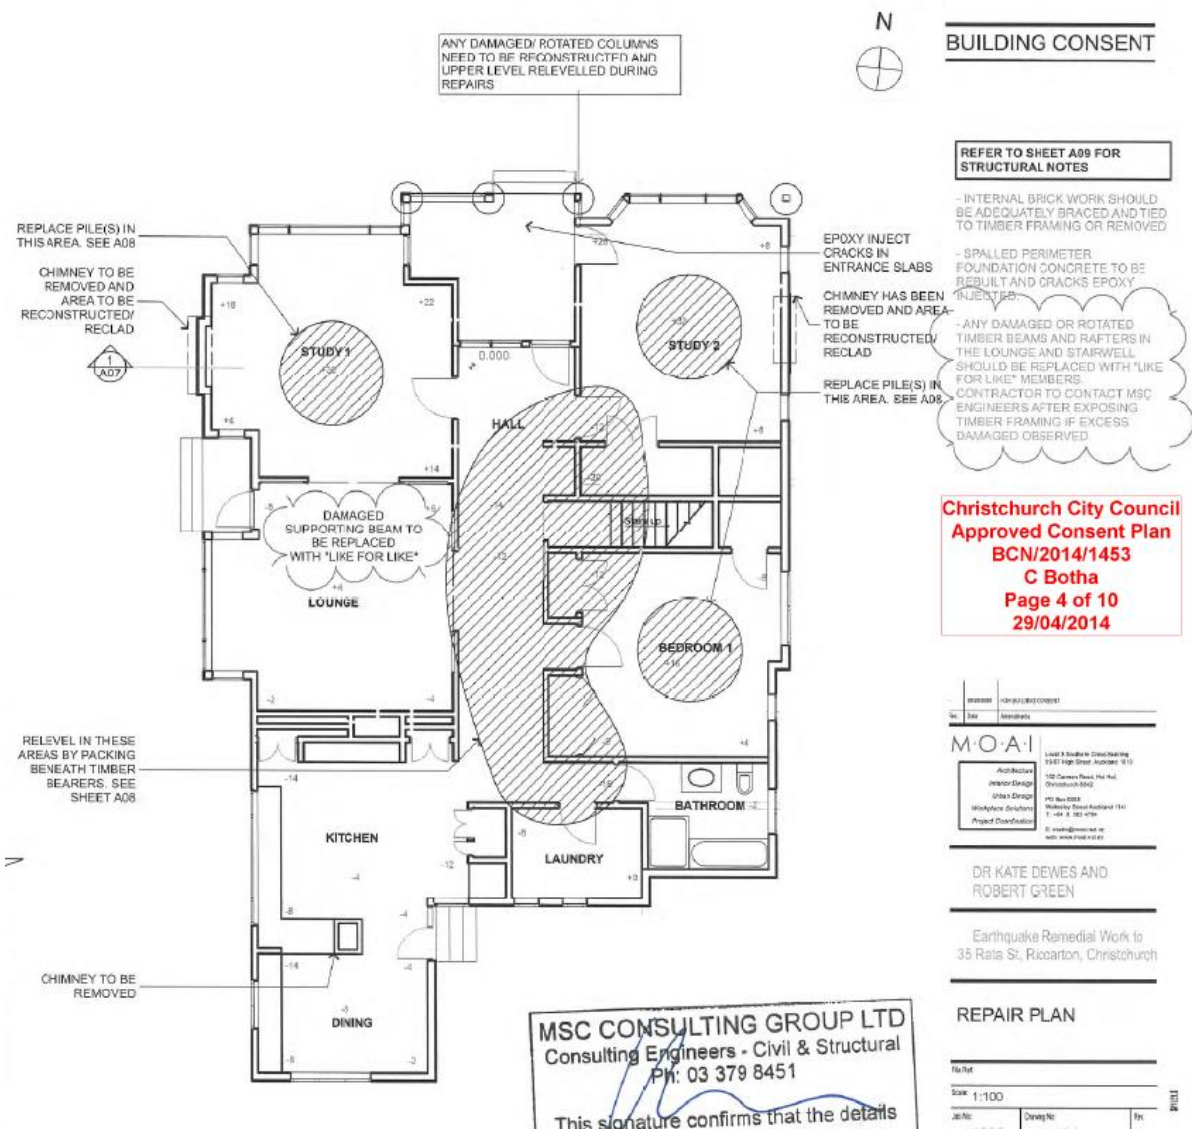
Figure 2: Consented plan for the ground floor

[47] Then, in 2013, MSC recommended, instead, that the ground floor be relevelled in the kitchen and hallway by jacking and packing to within the tolerances of the other areas, following which the cracks in the perimeter foundation and entranceway floor slabs would be injected with epoxy grout. WeirWalker Architects drew a plan of the ground floor of the house and incorporated into it the floor level measurements taken by MSC. It was this plan that was eventually modified and produced to the Christchurch City Council to support an application for a building consent. The consented plan for the ground floor can be found as Figure 2 in Appendix 1.

[51] Releveling of the kitchen/dining area, as recommended in the MSC plan, was not included in the consented plan.

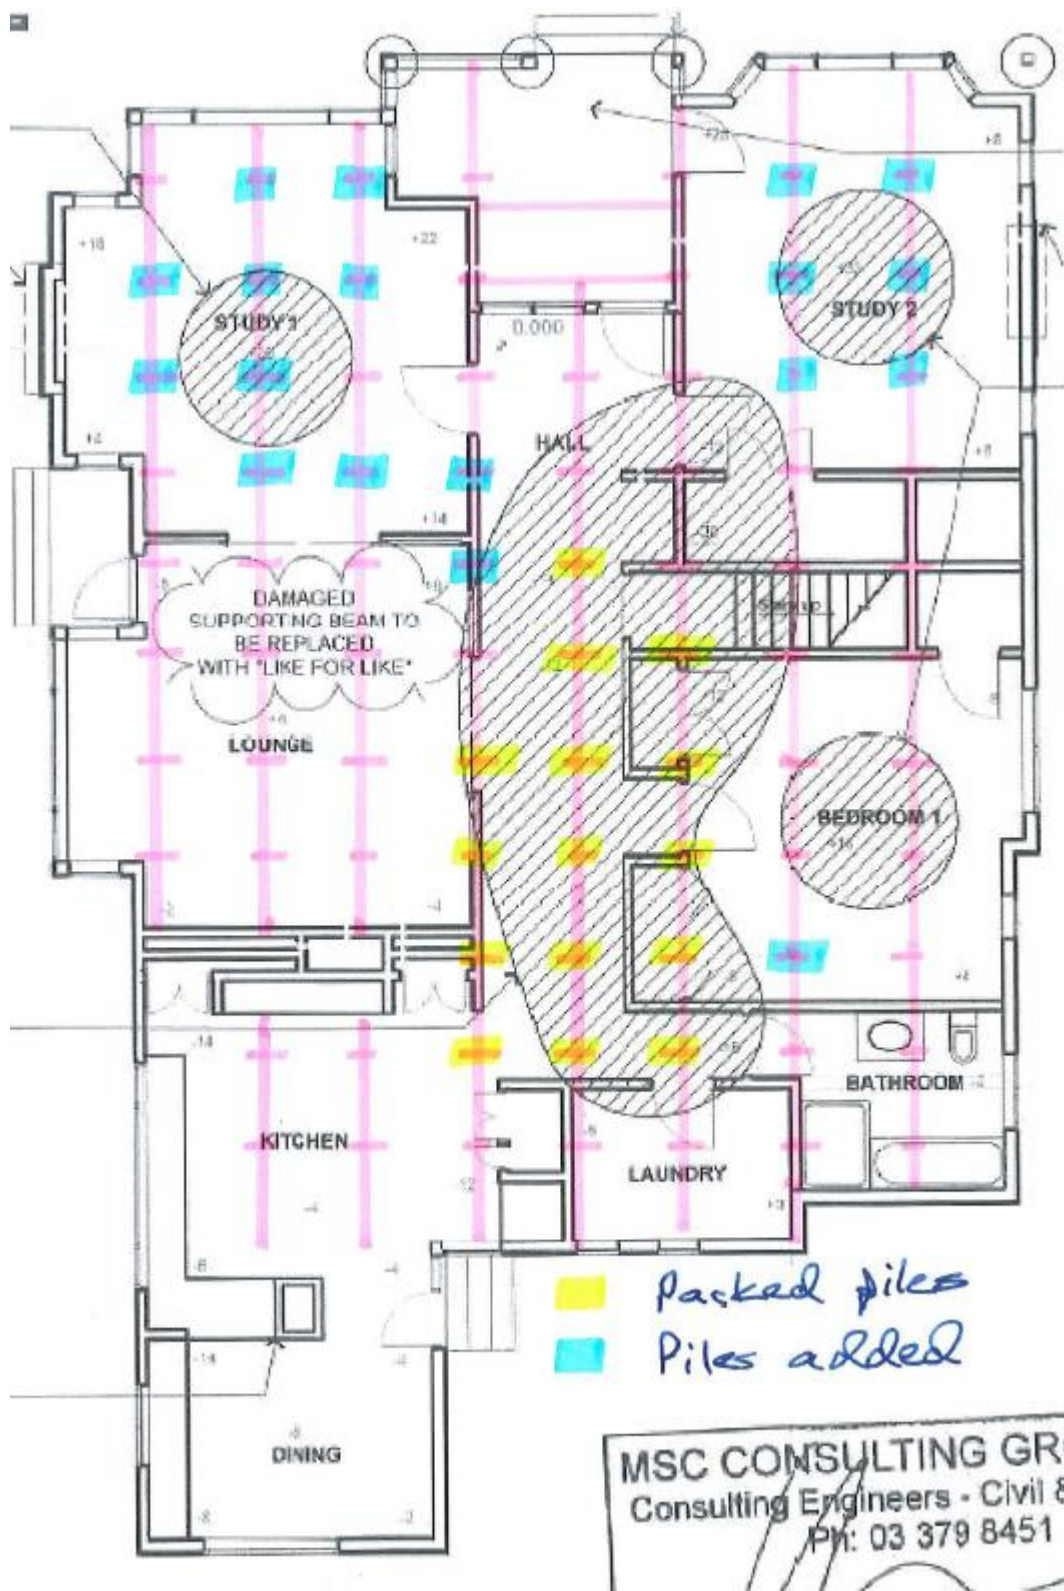
Figure 3: Location of subfloor repair works

attempted to locate these piles on the plan of the ground floor. Although the plan of the Cavity Critter photographs is not drawn to scale, it is possible to use the photographs to locate the approximate site where the bearers meet the north and south perimeter foundations. Nor is it too difficult to roughly identify where the piles are situated under the ground floor of the house, because they are evenly spaced under the bearers and run in lines across the house. Moreover, the Cavity Critter photographs can be used to identify which piles were packed, coinciding with those areas where the floor needed to be raised. It also appears from the photographs, that where the floor had high spots, the bearers in these areas were raised above the original piles by placing new piles on either side. This analysis reveals that the first technique was used under the hallway area and the second under the two studies. This is demonstrated in Figure 3 of Appendix 1.

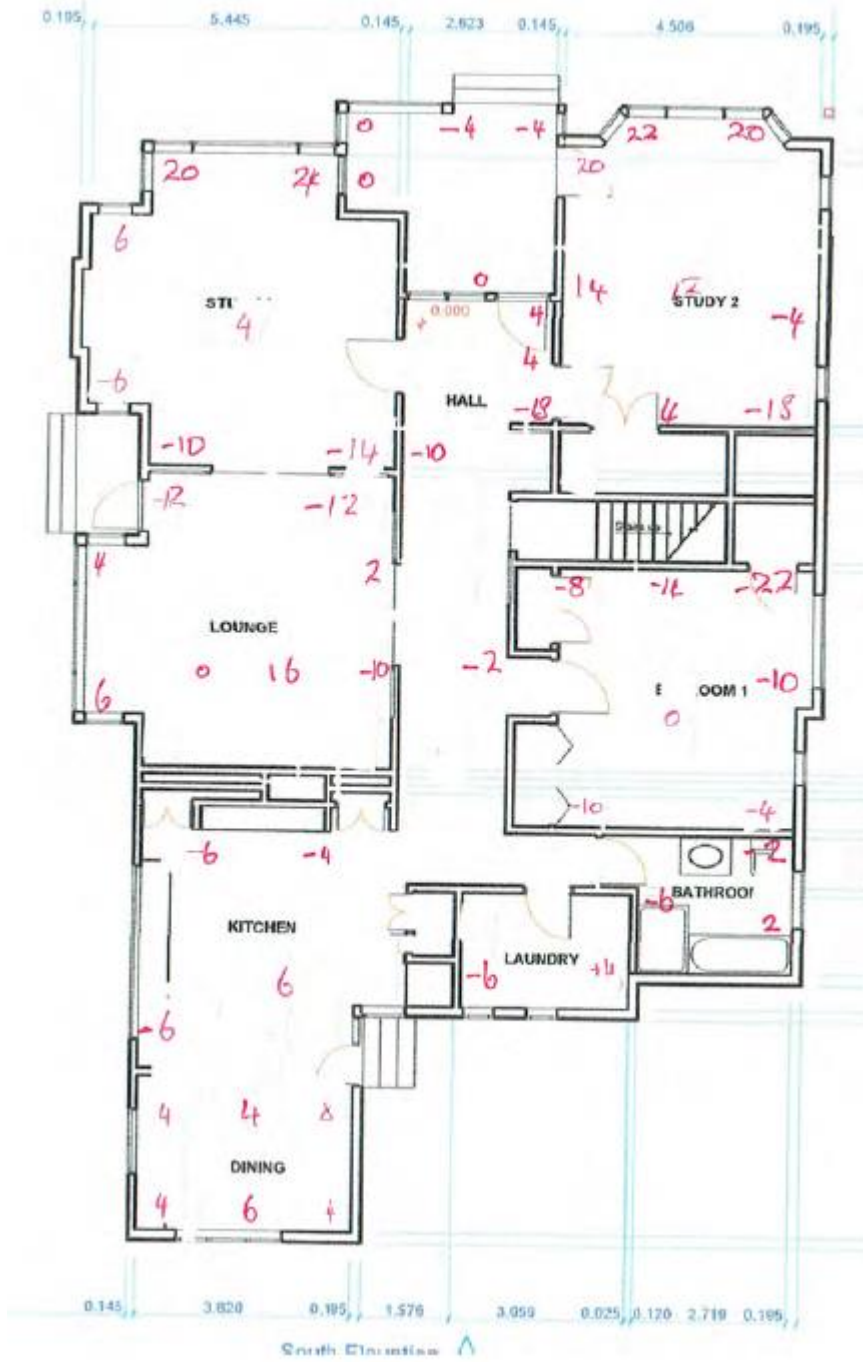
Figure 4: Terra Consultants ground floor post-repair floor level measurements

[54] Although Max Contracts raised the level of the bearers in studies 1 and 2 and packed the piles under the southern end of the hallway, there is no way of knowing how it identified its target floor levels, as the original floor level survey undertaken by MSC Consulting Group Limited (MSC) was inadequate and I heard no evidence from anyone who undertook or supervised the releveling. But I was provided with two floor level surveys, one made by Terra Consultants in May 2017 and the other made by Cook Costello in July 2018. Both surveys were based on a datum point just inside the front door and show the relativities between that datum point and the point at which the measurements were taken using plus and minus signs. These measurements need to be treated with some caution as they were taken in different places and on top of floor coverings. The other measurements in the Cook Costello survey are the heights of windowsills or interior door lintels at the point indicated by the arrow. The plans prepared from these surveys can be found in Appendix 1 as Figures 4 - 8.

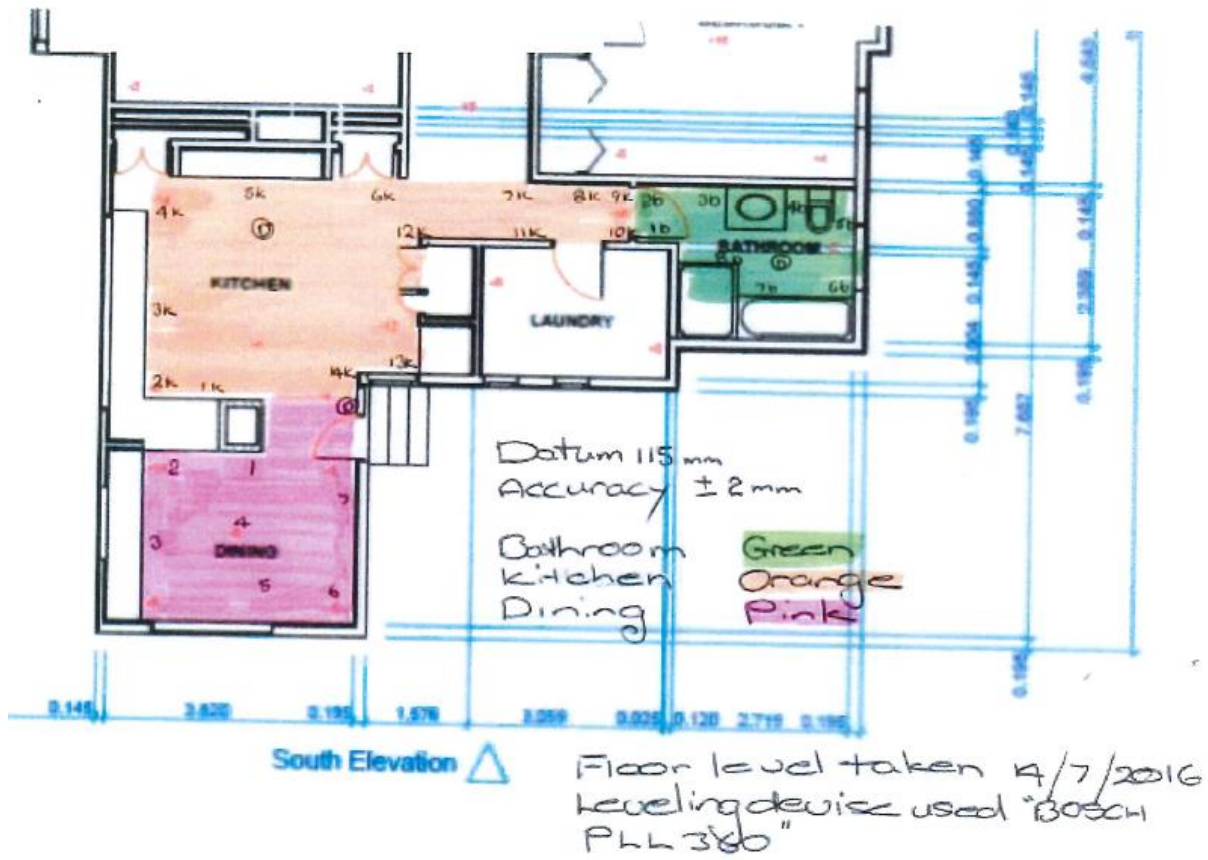
Figure 9: Richardson kitchen floor level measurements

[55] The Family Trust's building expert, Mr Richardson, also undertook a floor level survey. The plan he prepared from that survey, using a separate datum point for each room, can be found in Appendix 1 as Figure 9.

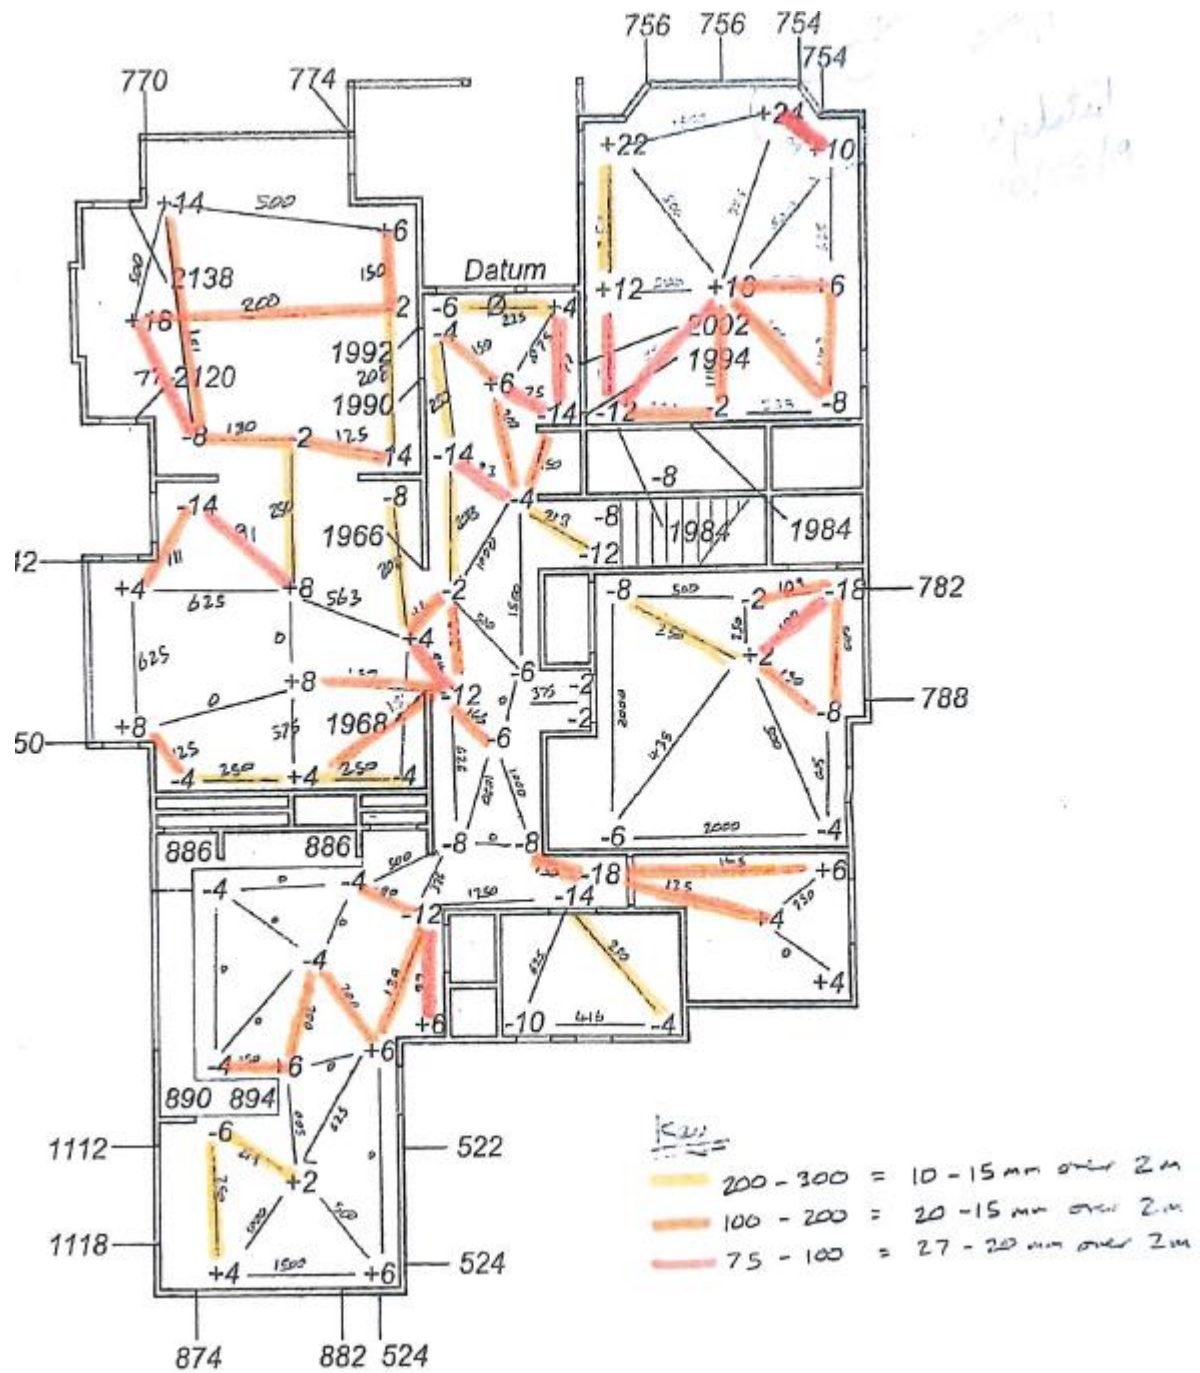
Figure 10: Critchley floor slope diagram

[56] The Family Trust's engineer, Ms Critchley, used the Cook Costello plan to prepare a floor slope diagram which can be found in Appendix 1 as Figure 10.

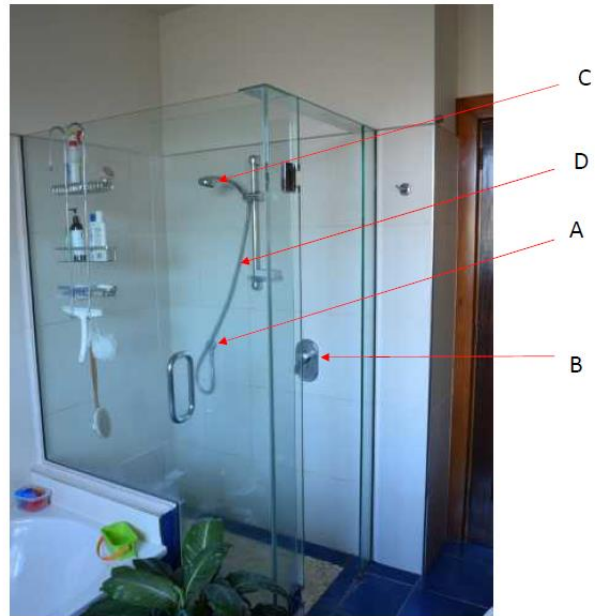
Figure 11: Shower

Arrow A indicates the point of very elevated moisture readings corresponding to this location on the plasterboard to the wall between the laundry and shower.

This point corresponds precisely with the connection of the shower hose (D) from the shower rose (C) to the supply from the shower mixer valve (B).
