IN THE MATTER OF CANTERBURY EARTHQUAKES INSURANCE
TRIBUNAL ACT 2019

BETWEEN BRL
Applicant

AND IAG
Second Respondent

RESERVED DECISION OF C P SOMERVILLE
13 July 2020

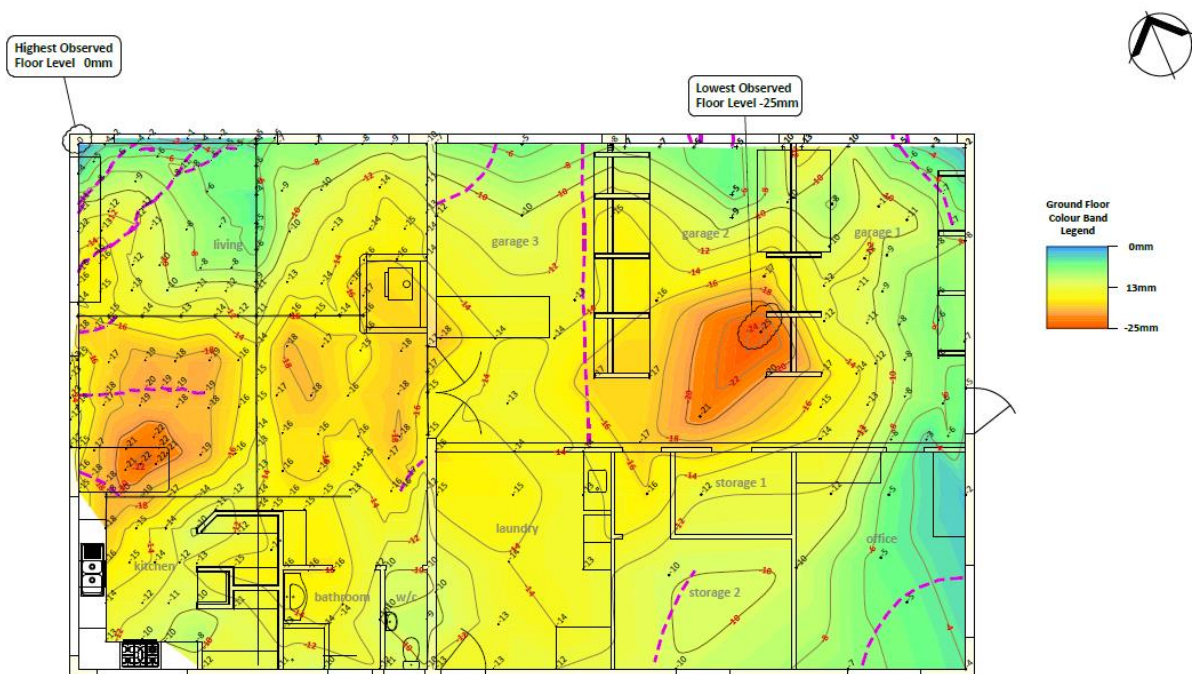
Figure 1: Floor levels, Contours, Coloured Height Bands, and visible cracks. 13 December 2016

[50] As can be seen, this plan was first issued in December 2016, more than six years after the September 2010 earthquake. The date on the plan, however, is the date upon which the plan was compiled and not the date (or dates) on which the measurements were made. Although much was made of the delay in preparing this plan, I do not believe that its credibility or accuracy is affected. It remains what it purports to be: a survey of the floor profile in late 2016.

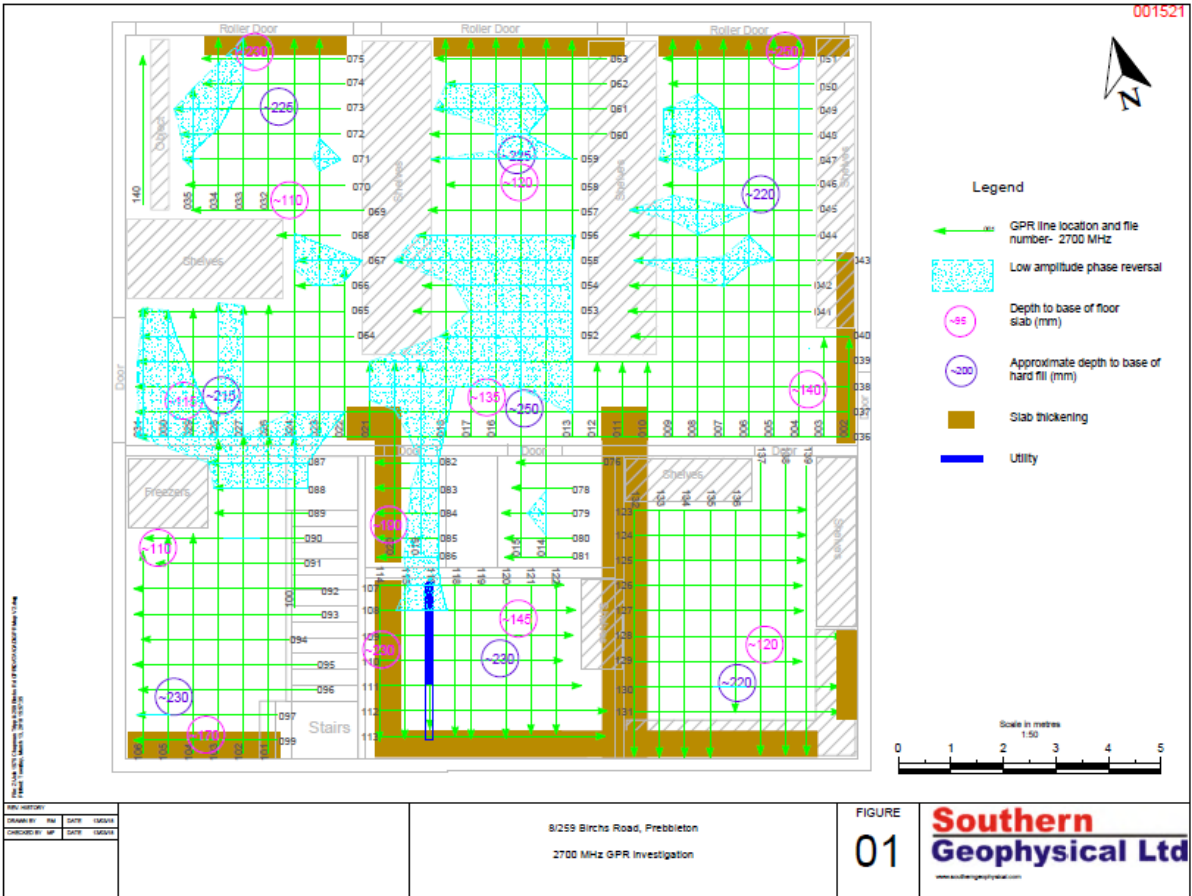
[67] Fortunately, as Figure 3 shows, Southern Geophysical Ltd, which undertook a Ground Penetrating Radar (GPR) survey of the floor in the eastern end of the building, was able to calculate the depth of the concrete floor slab. The accuracy of these results can be gauged from the fact that core sample 1 measuring 112 mm was taken close to a GPR reading at the left-hand edge of the diagram of 115 mm.

Figure 3: Depth to base of floor slab (red circles) from GPR survey

[68] If we ignore the readings taken alongside the perimeter or internal walls, which have deeper concrete footings, there are eight readings that range between 110 and 145 mm. This is a 35 mm range which can be expressed as ± 17.5 . This range is likely to contain tolerances for measurement, construction of a level surface on the base course, and construction of a level surface on the concrete slab. If we ignore the measurement tolerance and accept Mr Goodwin's evidence that he would expect a construction tolerance of ± 6 mm in levelment of a modern concrete slab, then that leaves a ± 12 mm tolerance for laying the base course. That ratio of 1:2 seems reasonable having regard to the more accurate method used to place the concrete than to lay the base course.

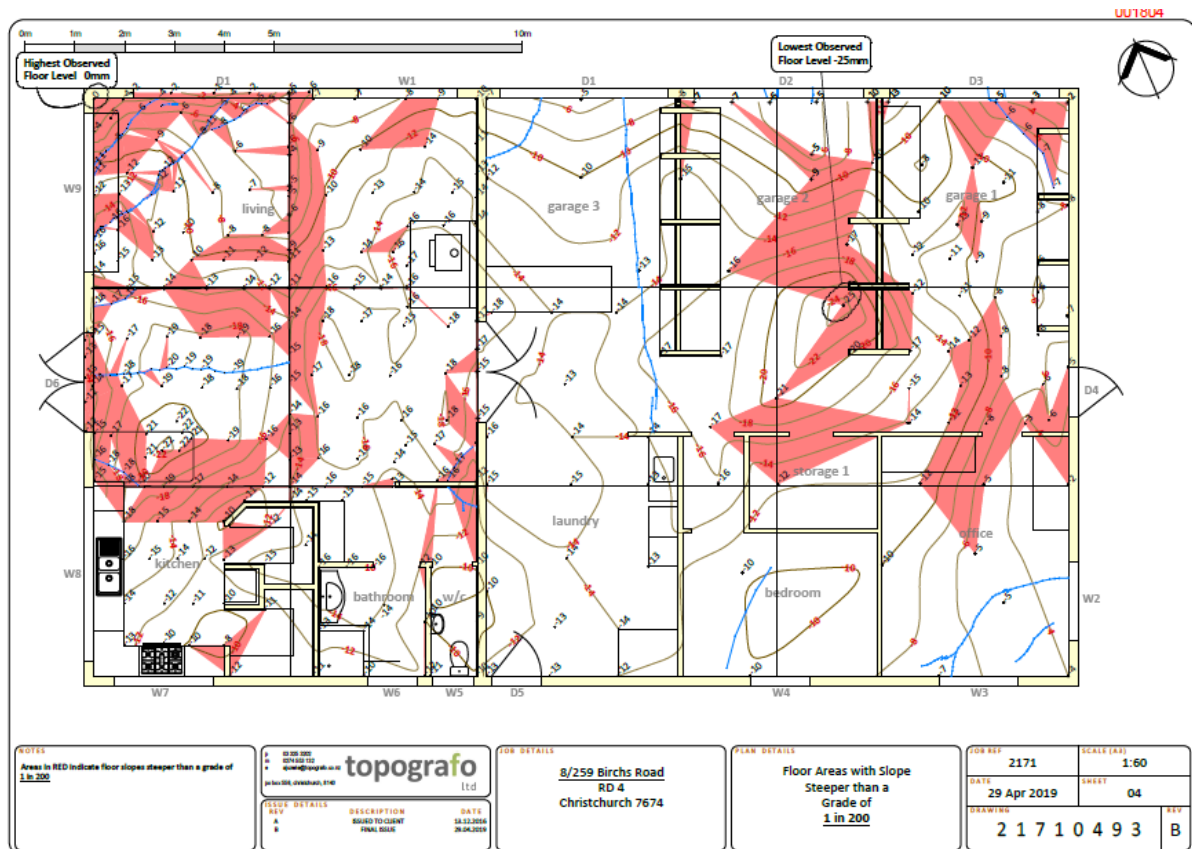
[81] The three engineers who signed the JER recorded that “approximately 20% of the ground floor has floor slopes steeper than a grade of one in 200 (0.5%).” It is widely recognised that any floor slope that exceeds 1:200 is perceptible and breaches the provisions in the New Zealand Building Code relating to amenity. Mr Cowie’s diagram of those areas is shown at Figure 4.

Figure 4: Floor slopes steeper than 1:200

[82] The offending slopes are predominantly in the north-eastern and north-western corners of the building, often immediately adjacent to the perimeter boxing. Bearing in mind that these are perceptible slopes which would have been obvious to the concrete placers, those adjacent to the perimeter boxing are unlikely to be due to construction tolerances. Some other factor is responsible.

[84] Figure 4 shows, in blue, the location of the cracks in the floor slab. Mr Cowie acknowledges that the crack running through the garage was present prior to the earthquake but exacerbated during it. He says that the other cracks appeared afterwards. Mrs Cowie corroborates this evidence.

[86] Figure 4 indicates that there are other less noticeable grade changes coinciding with cracks, particularly the crack in the north-eastern corner.

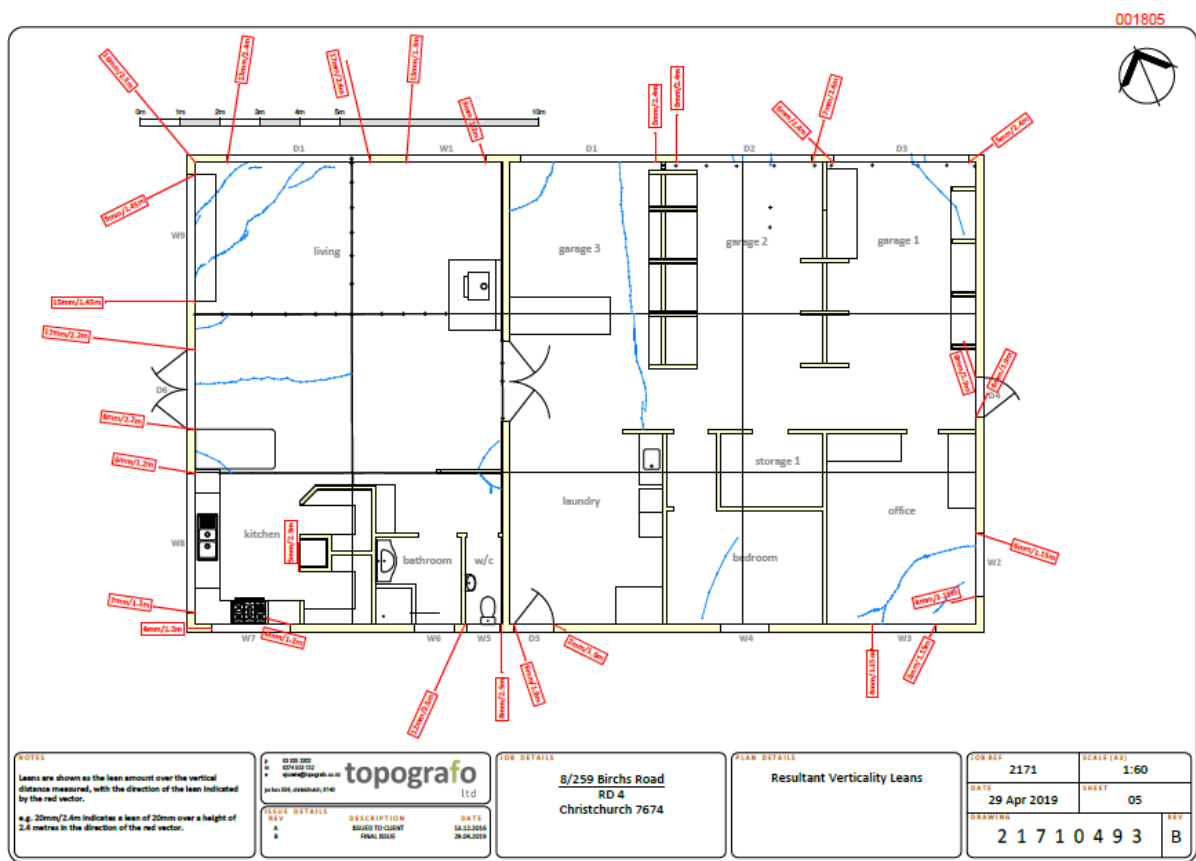
[101] Mr Cowie surveyed all window and door openings around the building and produced the diagram shown as Figure 5.

Figure 5: Verticality Leans

[102] Although some sections of the portal frame are exposed (in parts of the garage area and on the mezzanine floor) no attempt has been made to measure their verticality. Conversely, some measurements were taken at my request of the wall adjacent to sections of the portal
