## B2: Long List of Spoil Sites Assessed in MCA Process

### Final Spoil Sites Recommended for Consenting

Through the preparation of the Detailed Business Case (DBC) it was identified that the current earthworks design of the Ō2NL Project relies on a significant amount of fill, exceeding the amount of material that is anticipated to be won through earthwork cut activities. The current design (Revision DF5.0 – dated May 2022) is based on a shortfall of 800,000 to 1,500,000+ m<sup>3</sup> of earth material being found (or imported) for structural embankment fill. Design constraints, notably grade separating local roads from the highway, topography and geological conditions, cause this unfavourable cut/fill material balance.

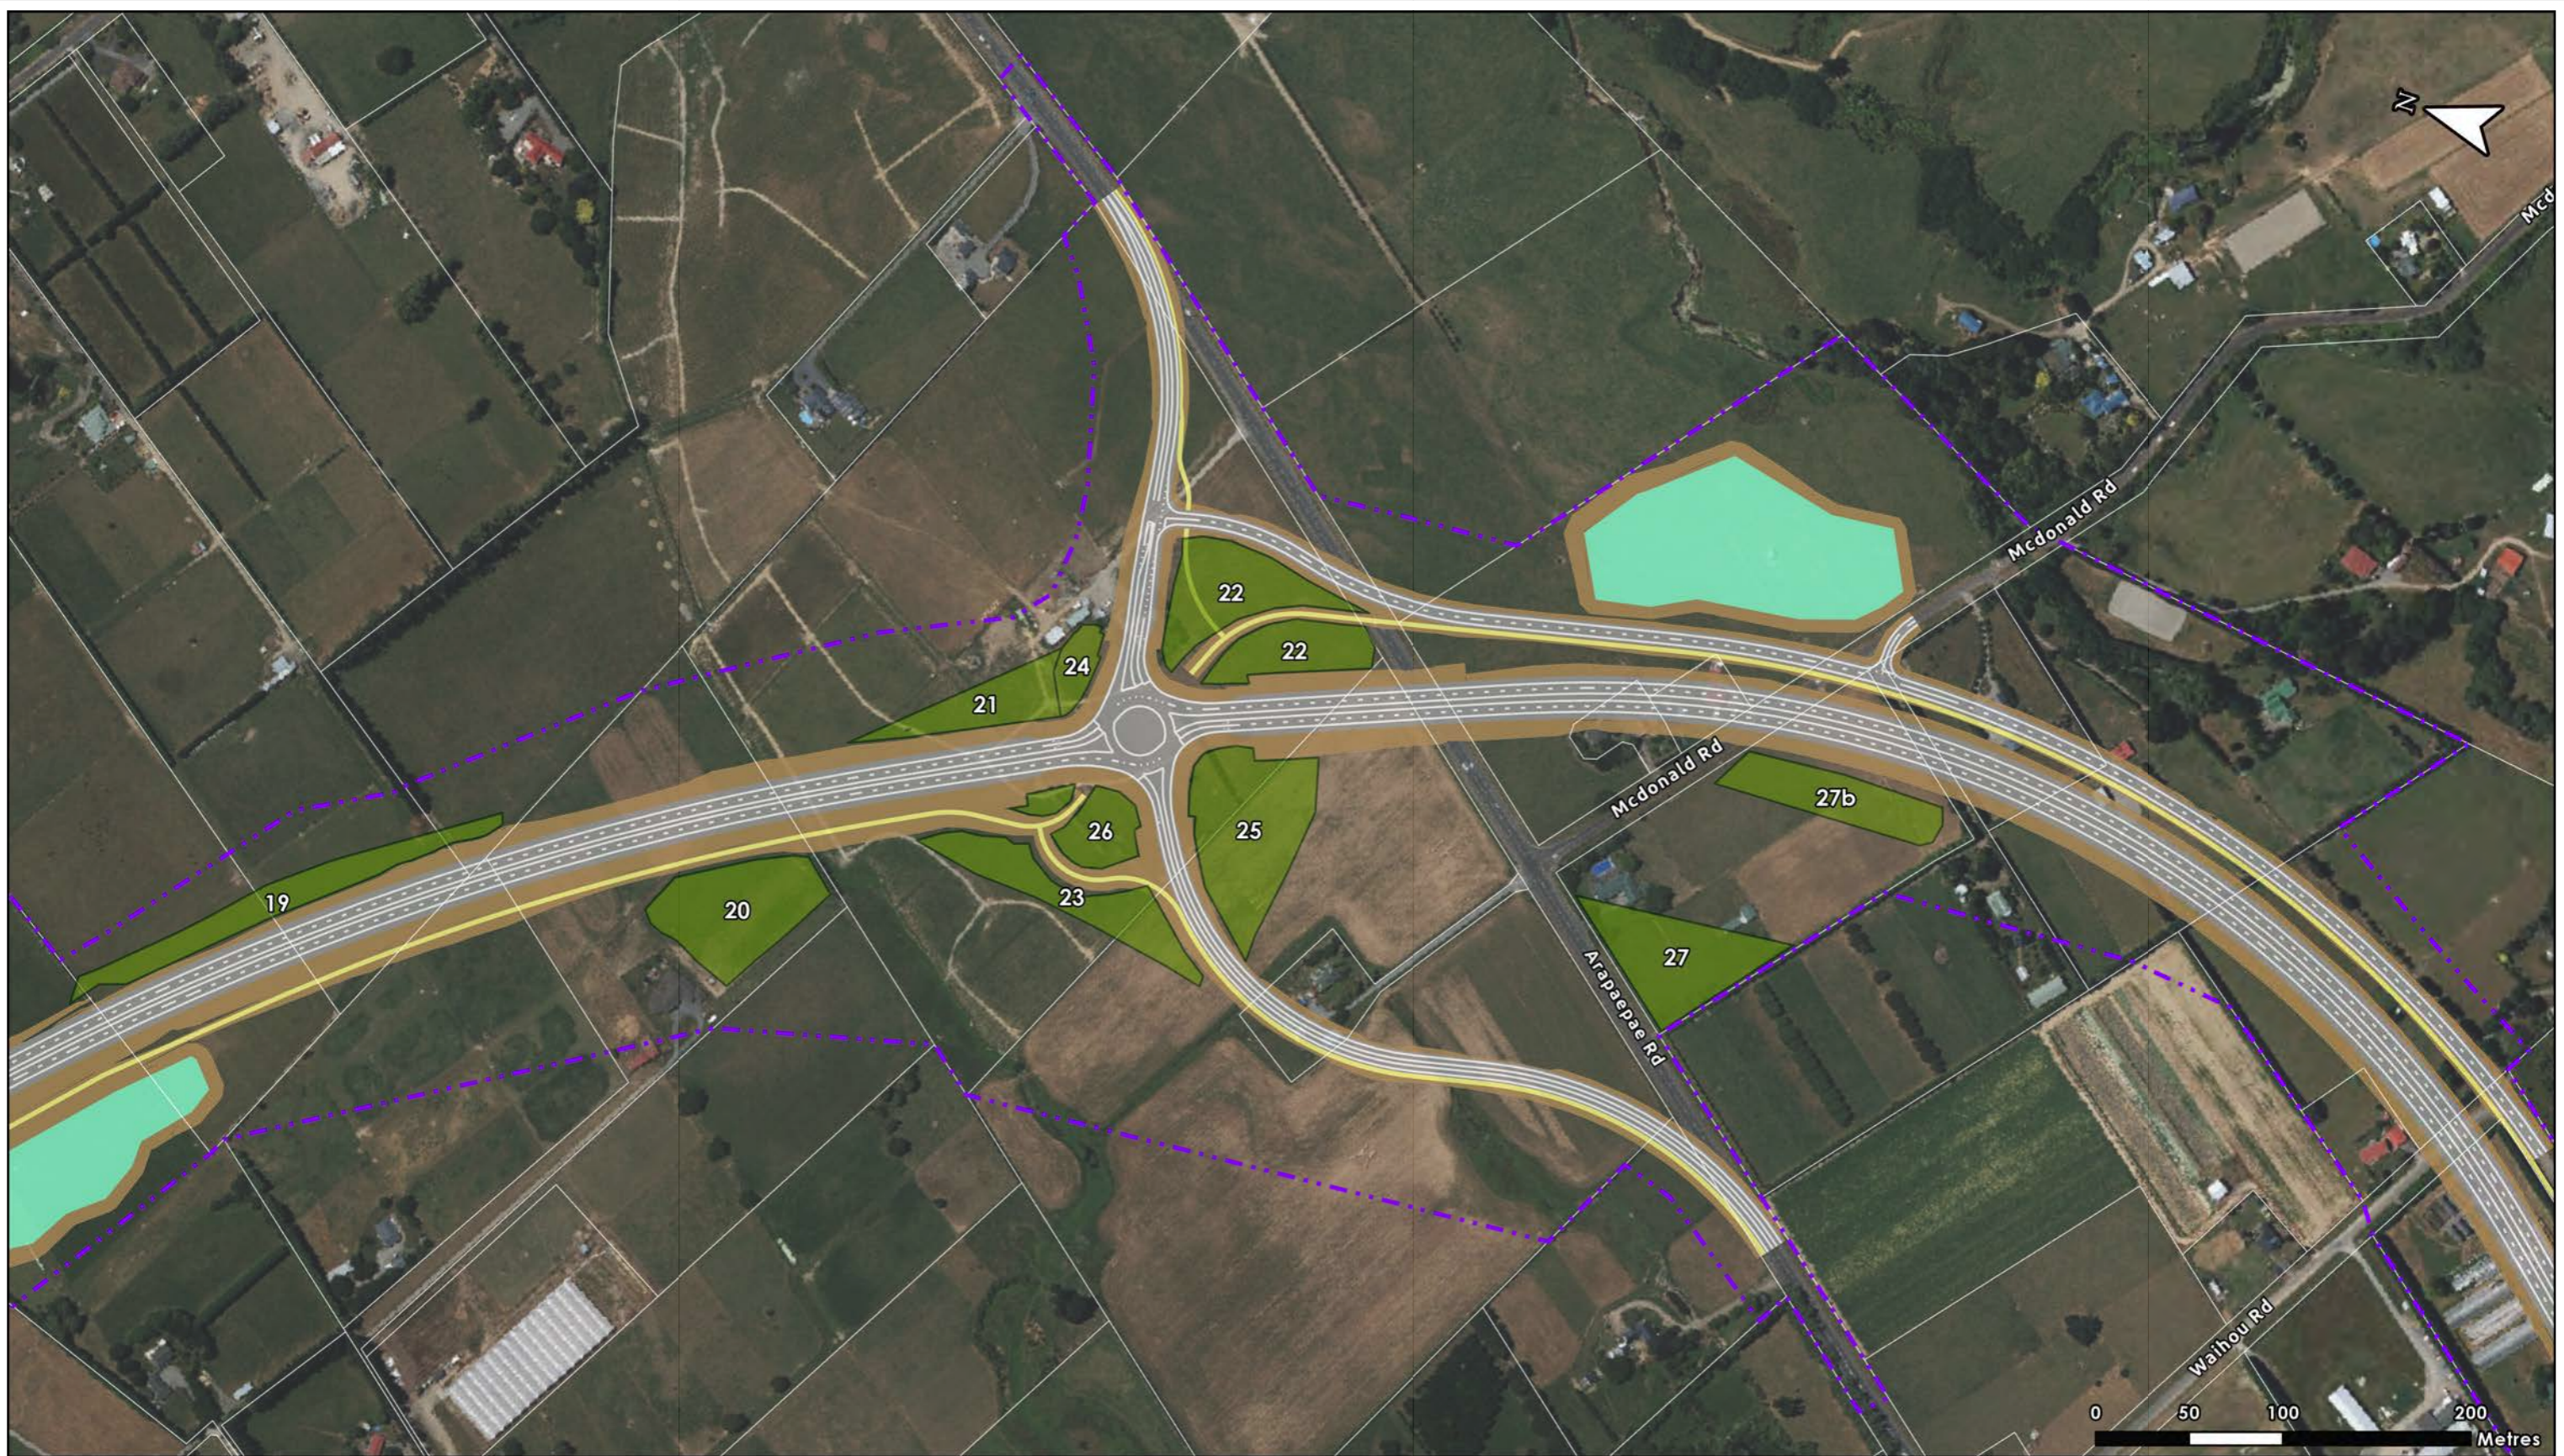
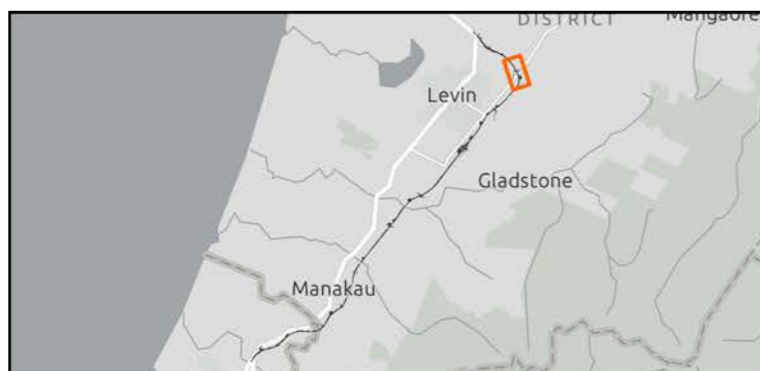
Chainage 12400 - 14000

### Final Spoil Sites Recommended for Consenting

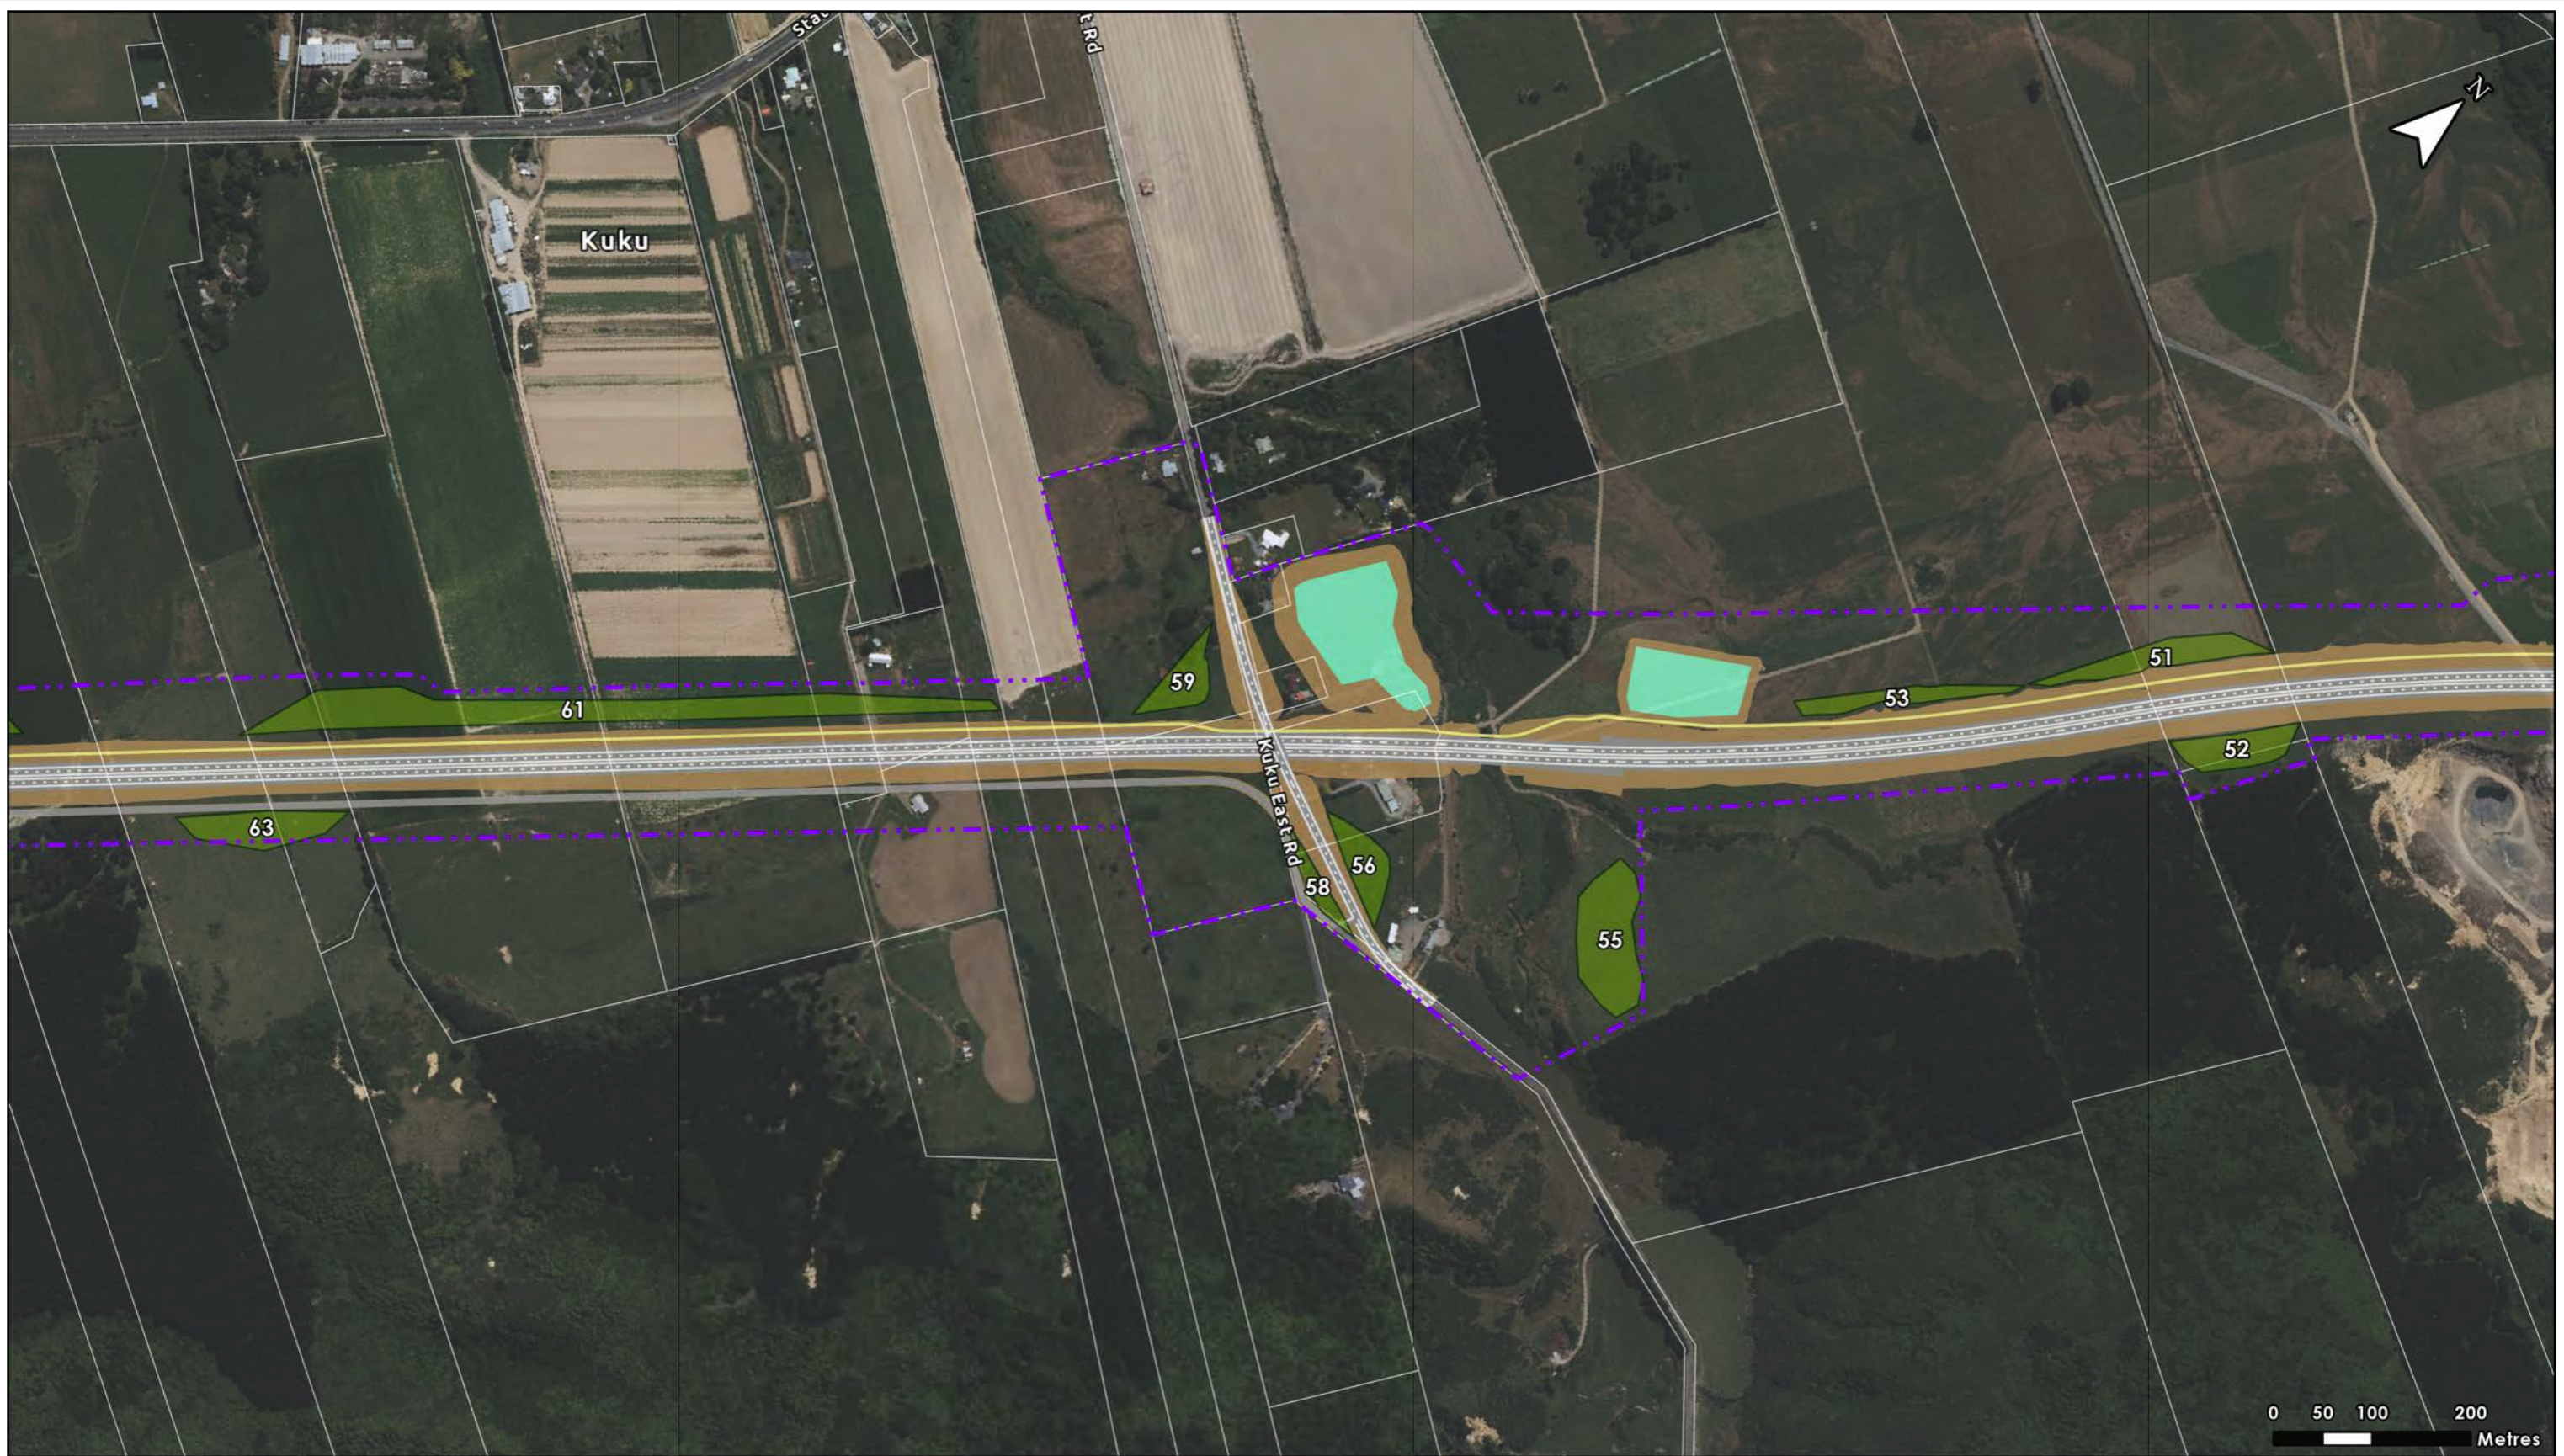
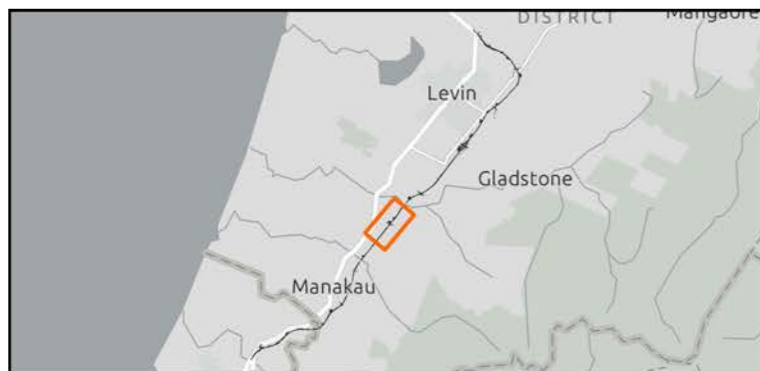
Chainage 22800 - 25100

### Final Spoil Sites Recommended for Consenting

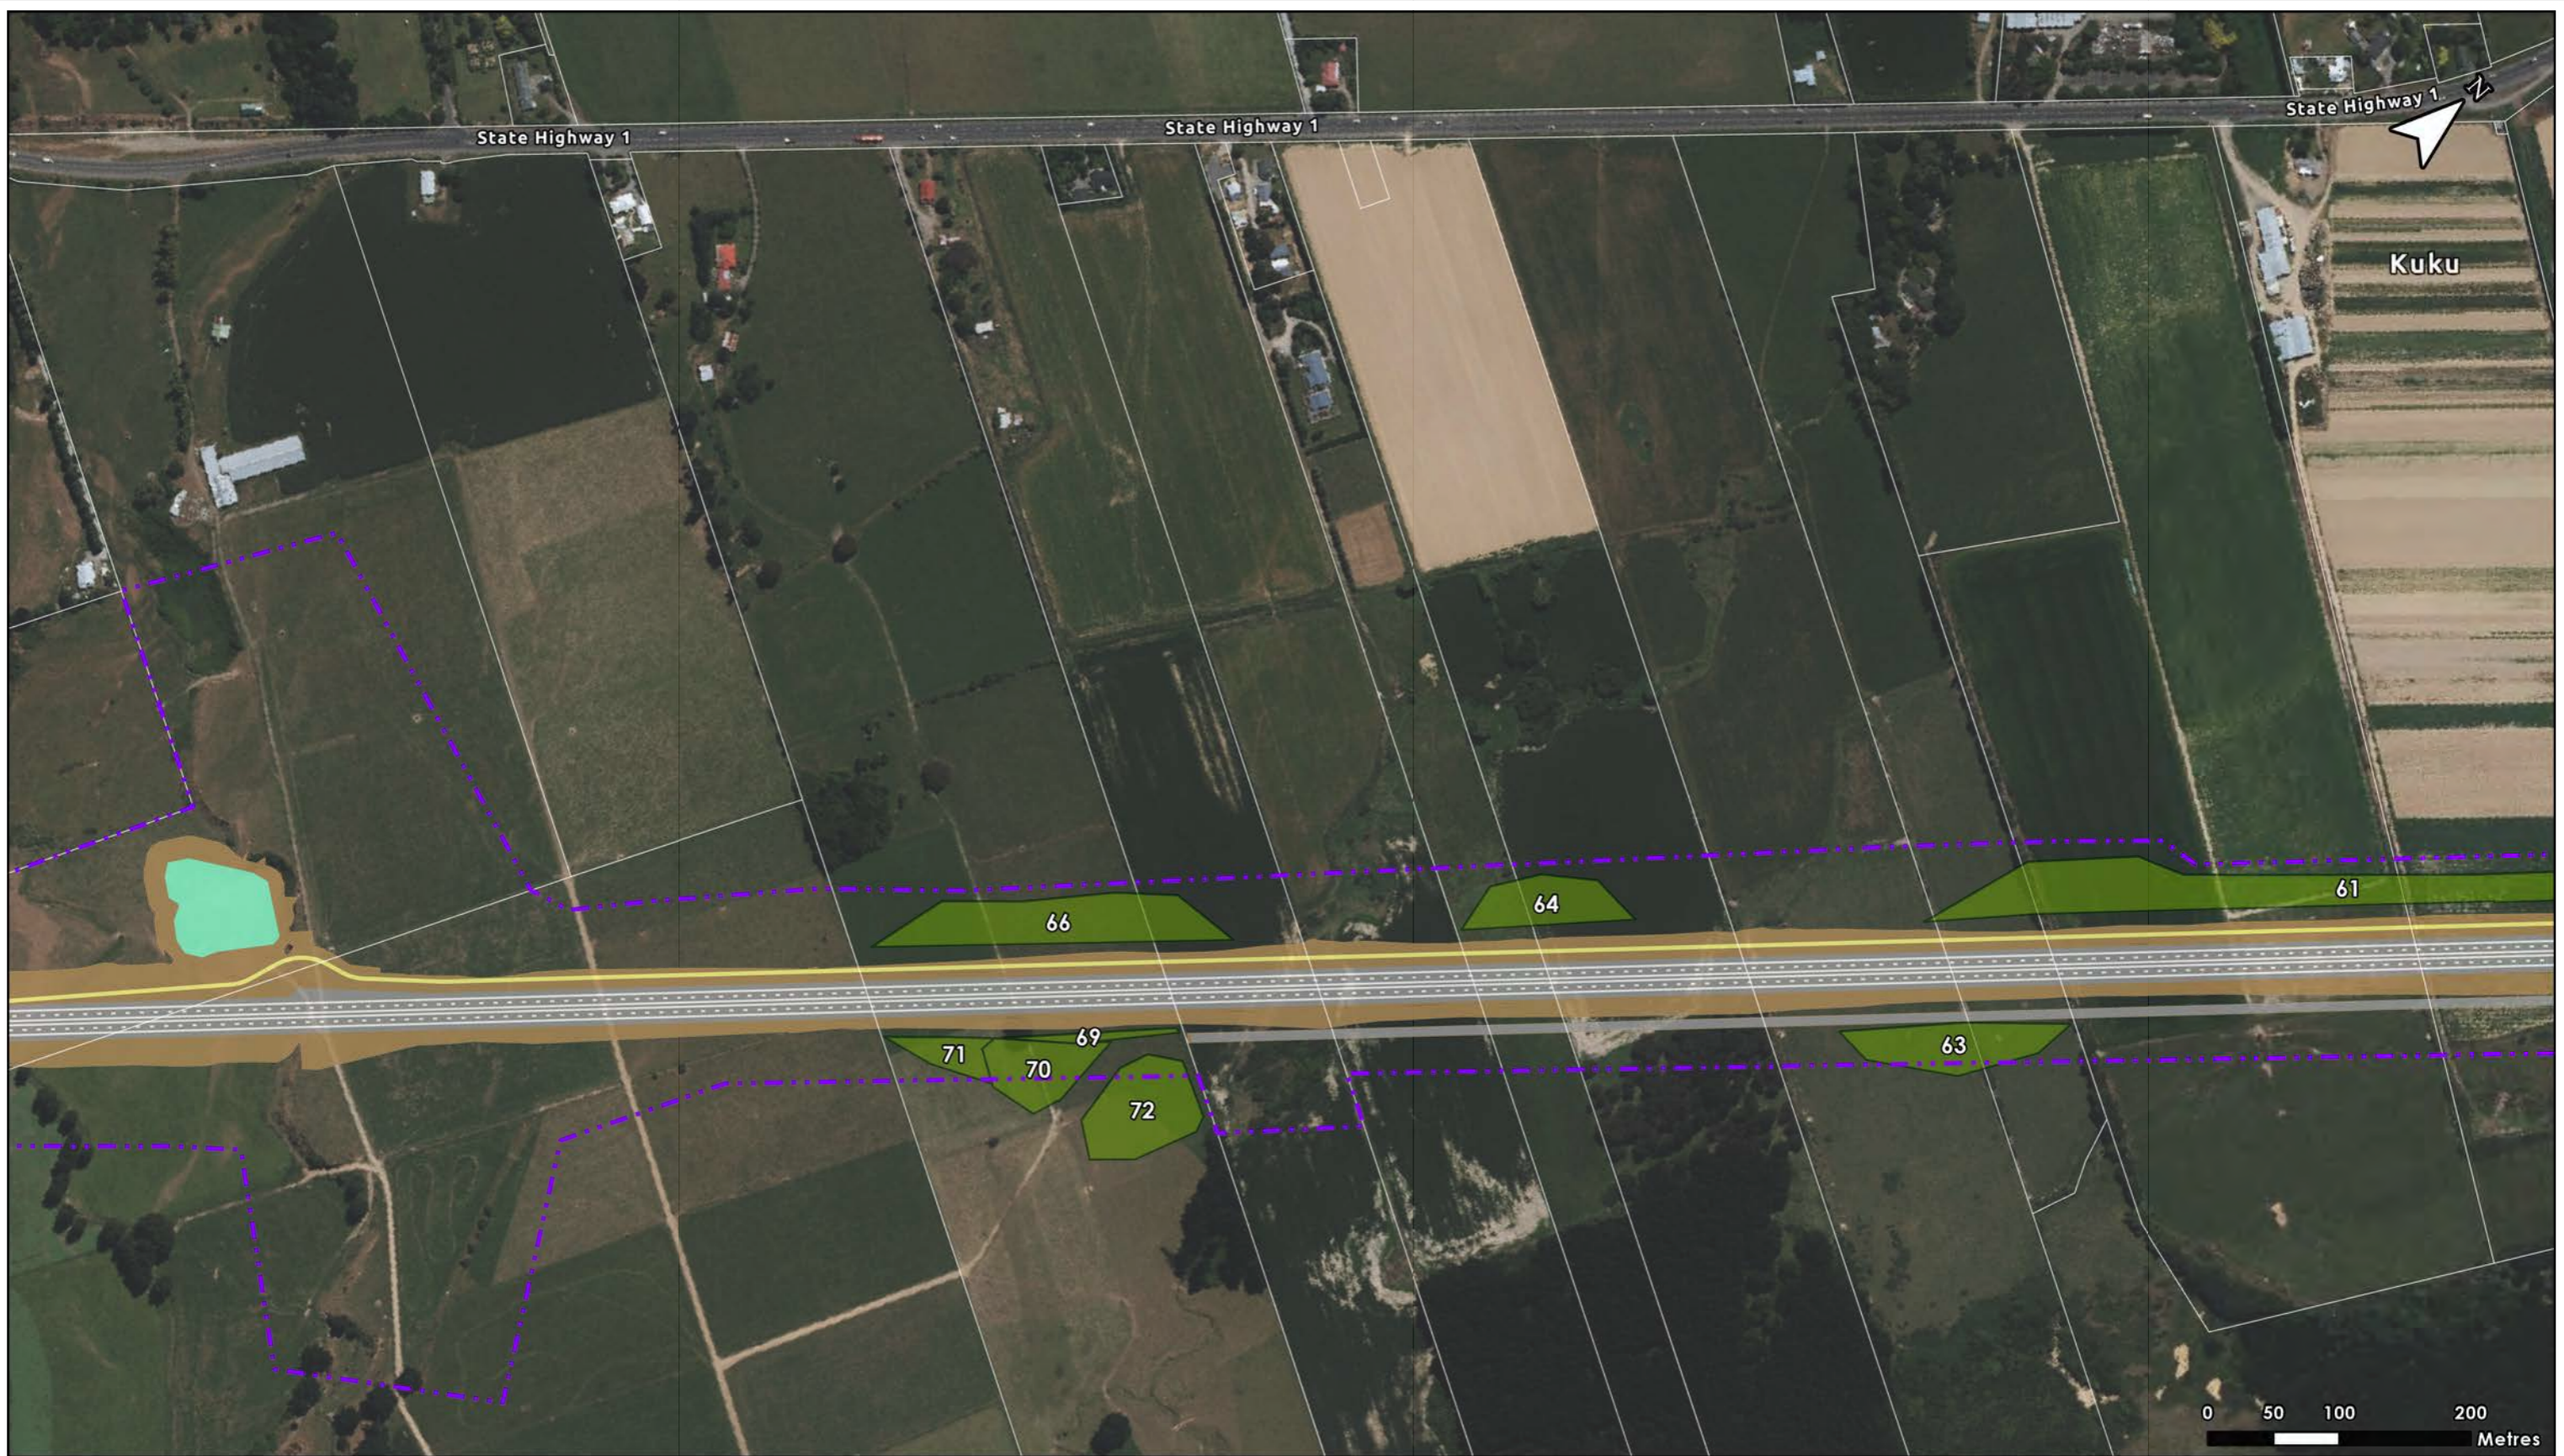
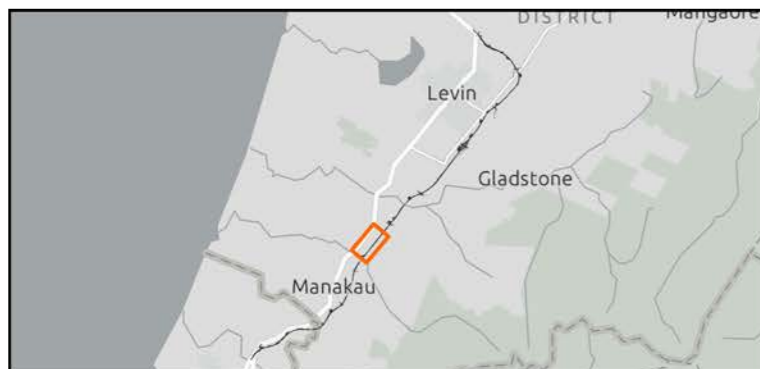
<h3>Final Spoil Sites Recommended for Consenting</h3> <p>Chainage 24600 - 26200</p>	
<p><small>Data Sources: Stantec, Land Information New Zealand Basemap sourced from Land Information New Zealand. Map projected in NZGD 2000 New Zealand Transverse Mercator coordinate system.</small></p>	<p><small>Author: mcpherson, Stantec (2022) Reviewed by: egkeli, jgesche, Stantec (2022) Project Code: 310203848 Export Date: 05/8/2022</small></p>

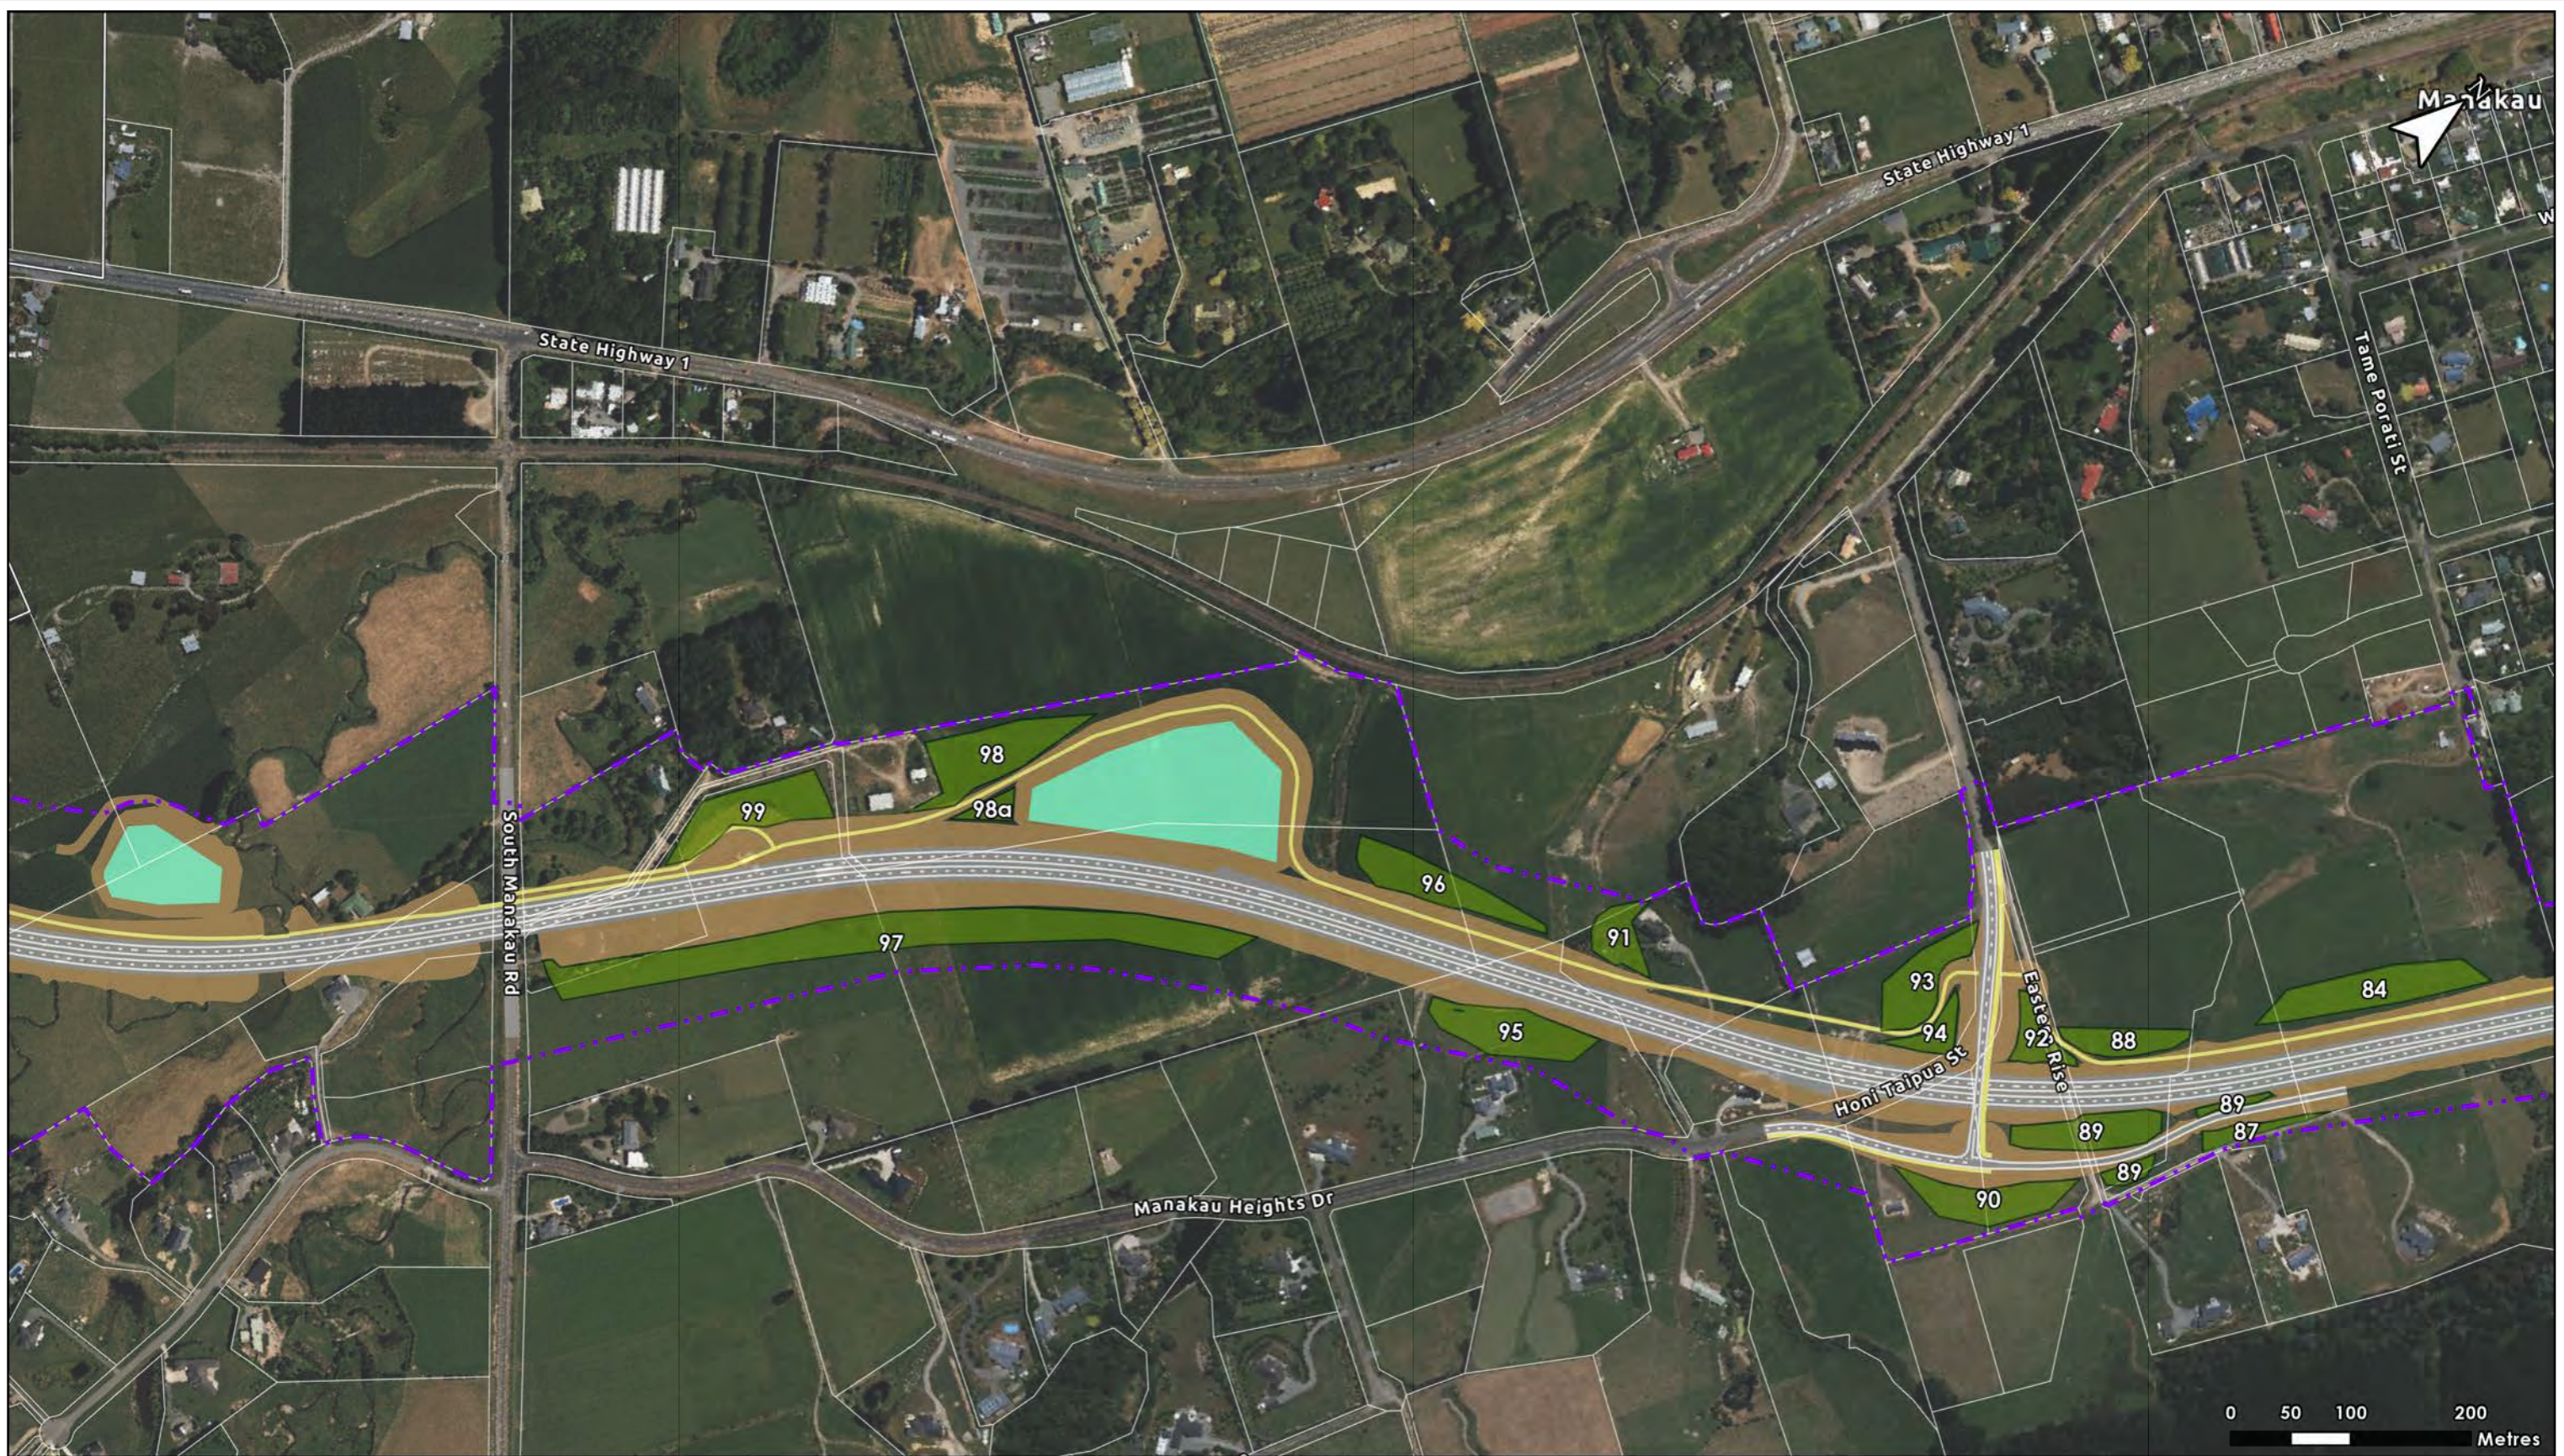
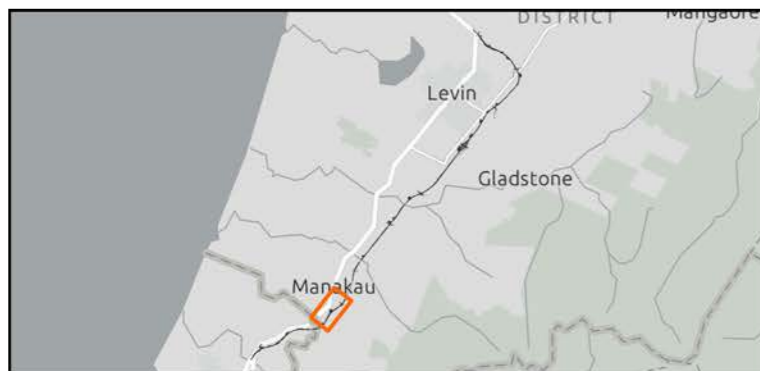
Chainage 28500 - 30500

### Final Spoil Sites Recommended for Consenting

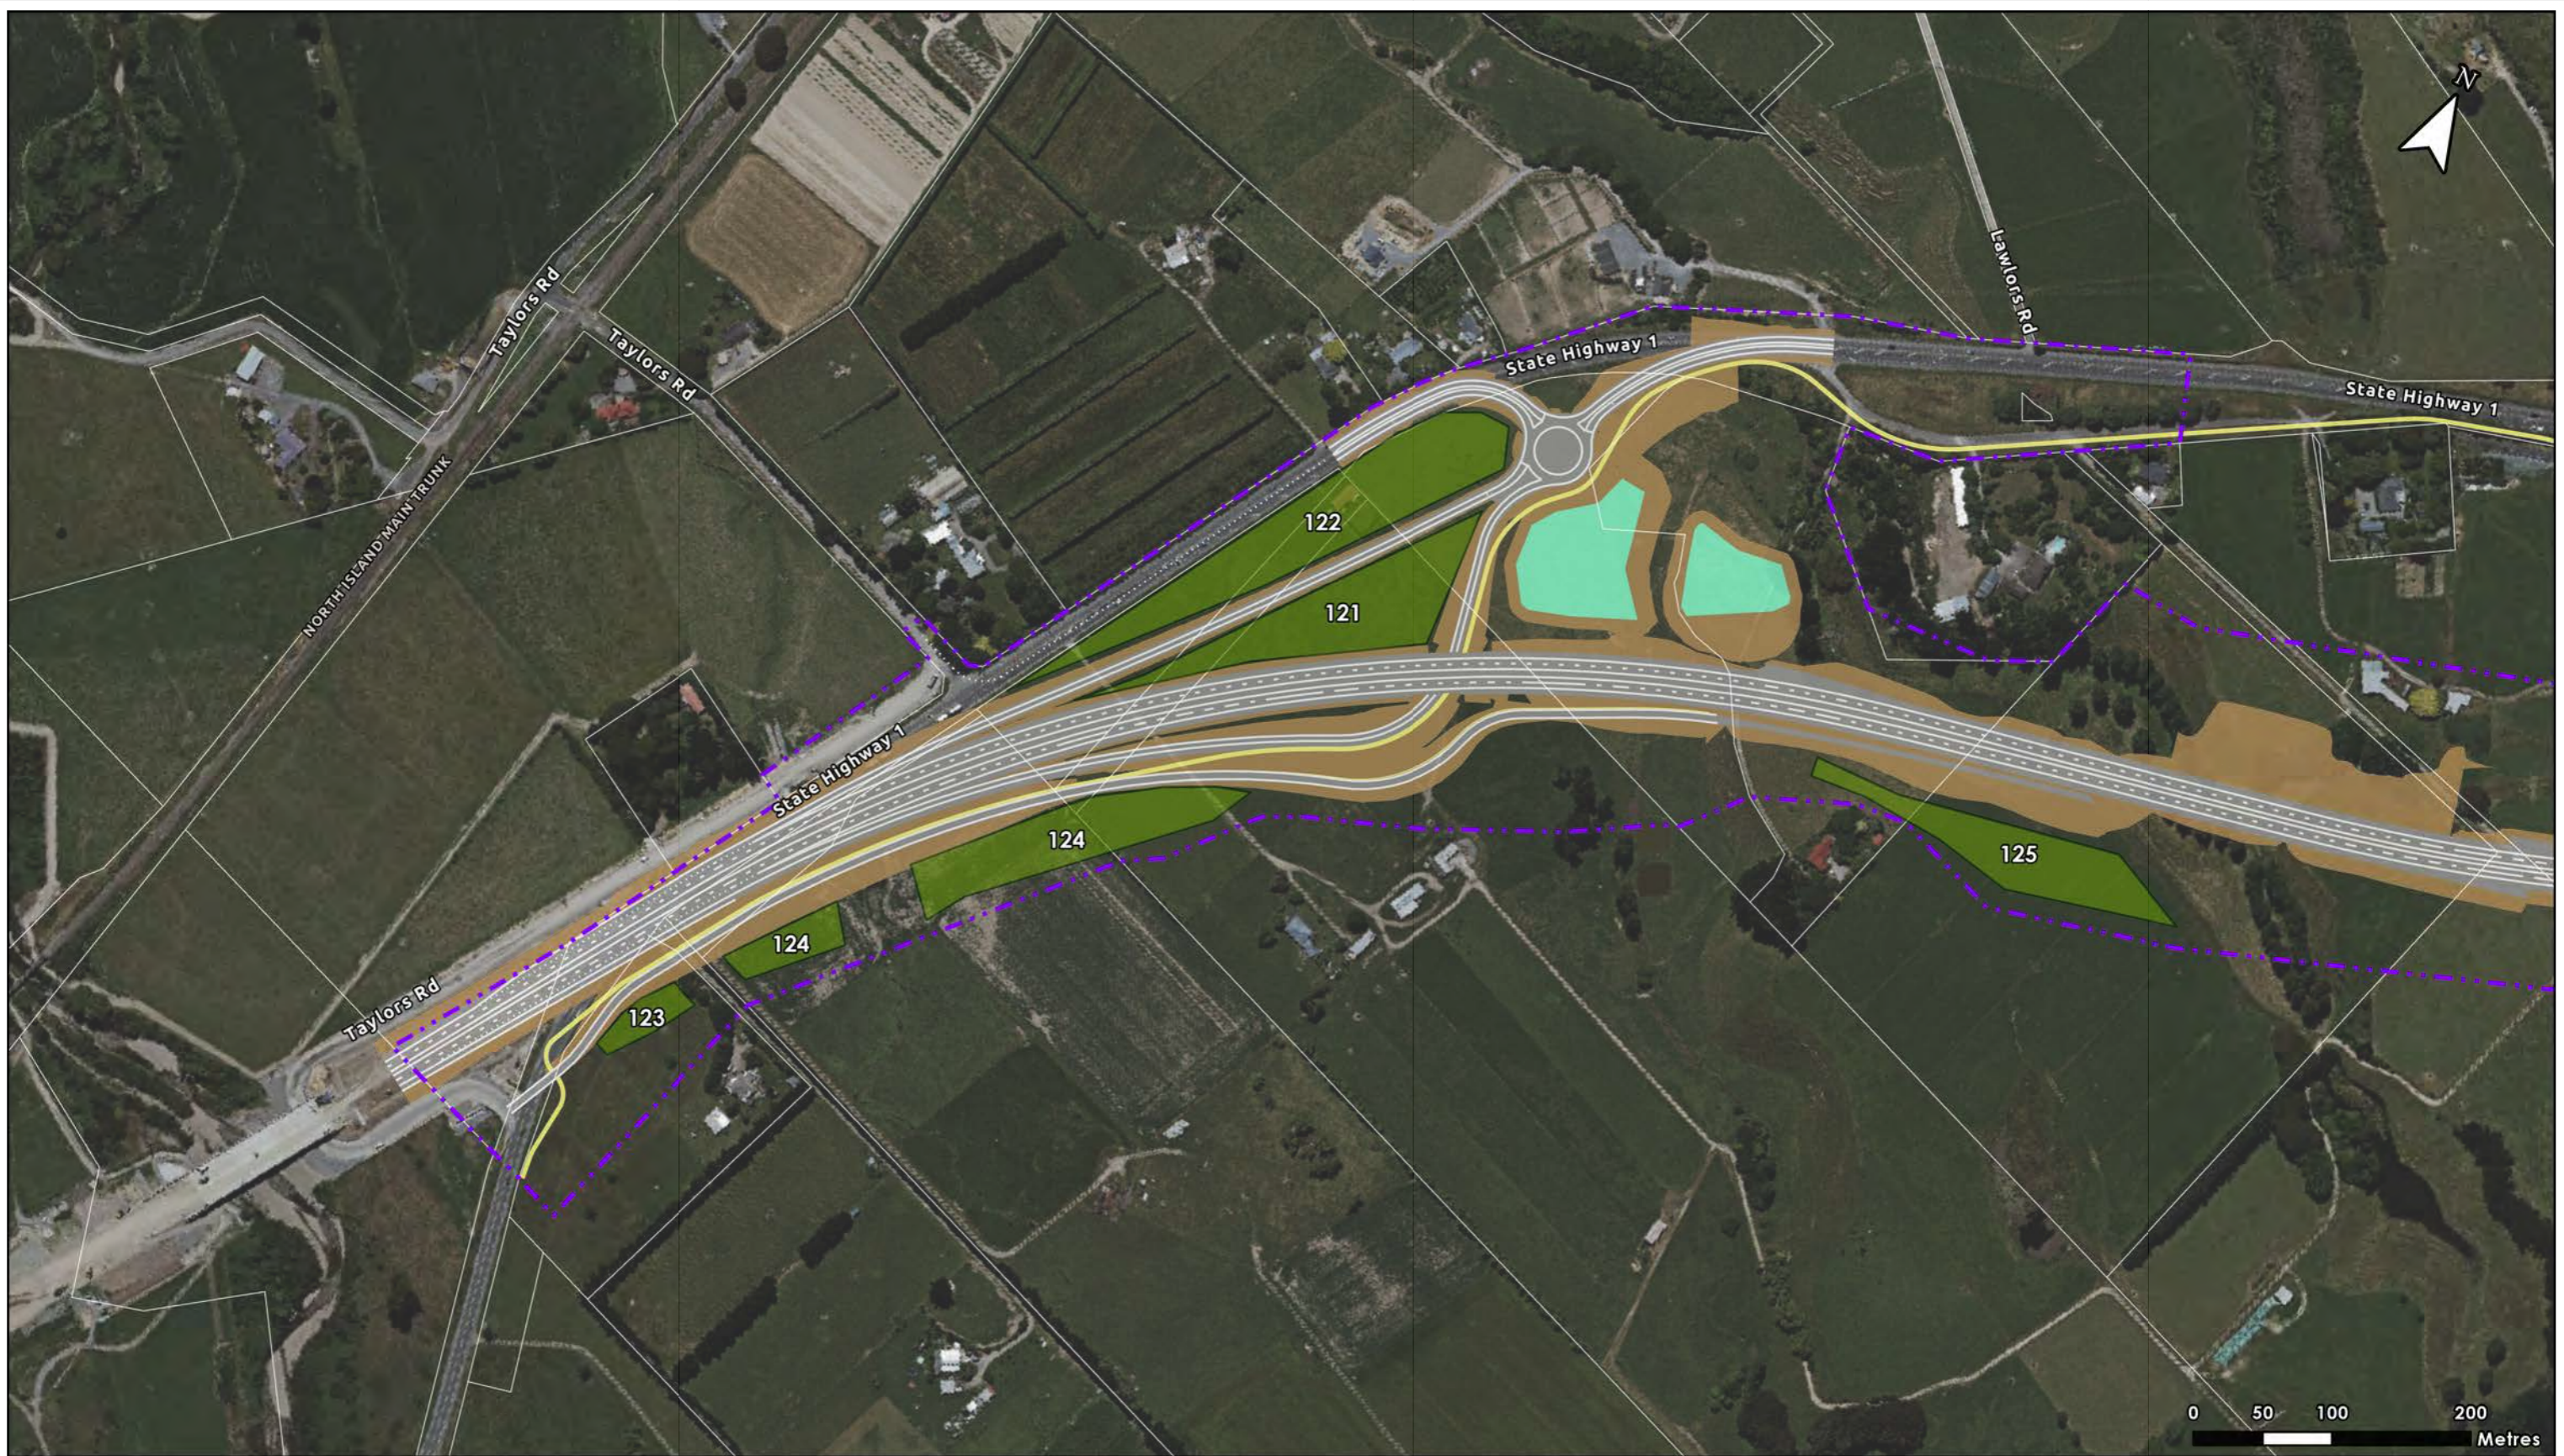
Chainage 33600 - 35000

### Final Spoil Sites Recommended for Consenting

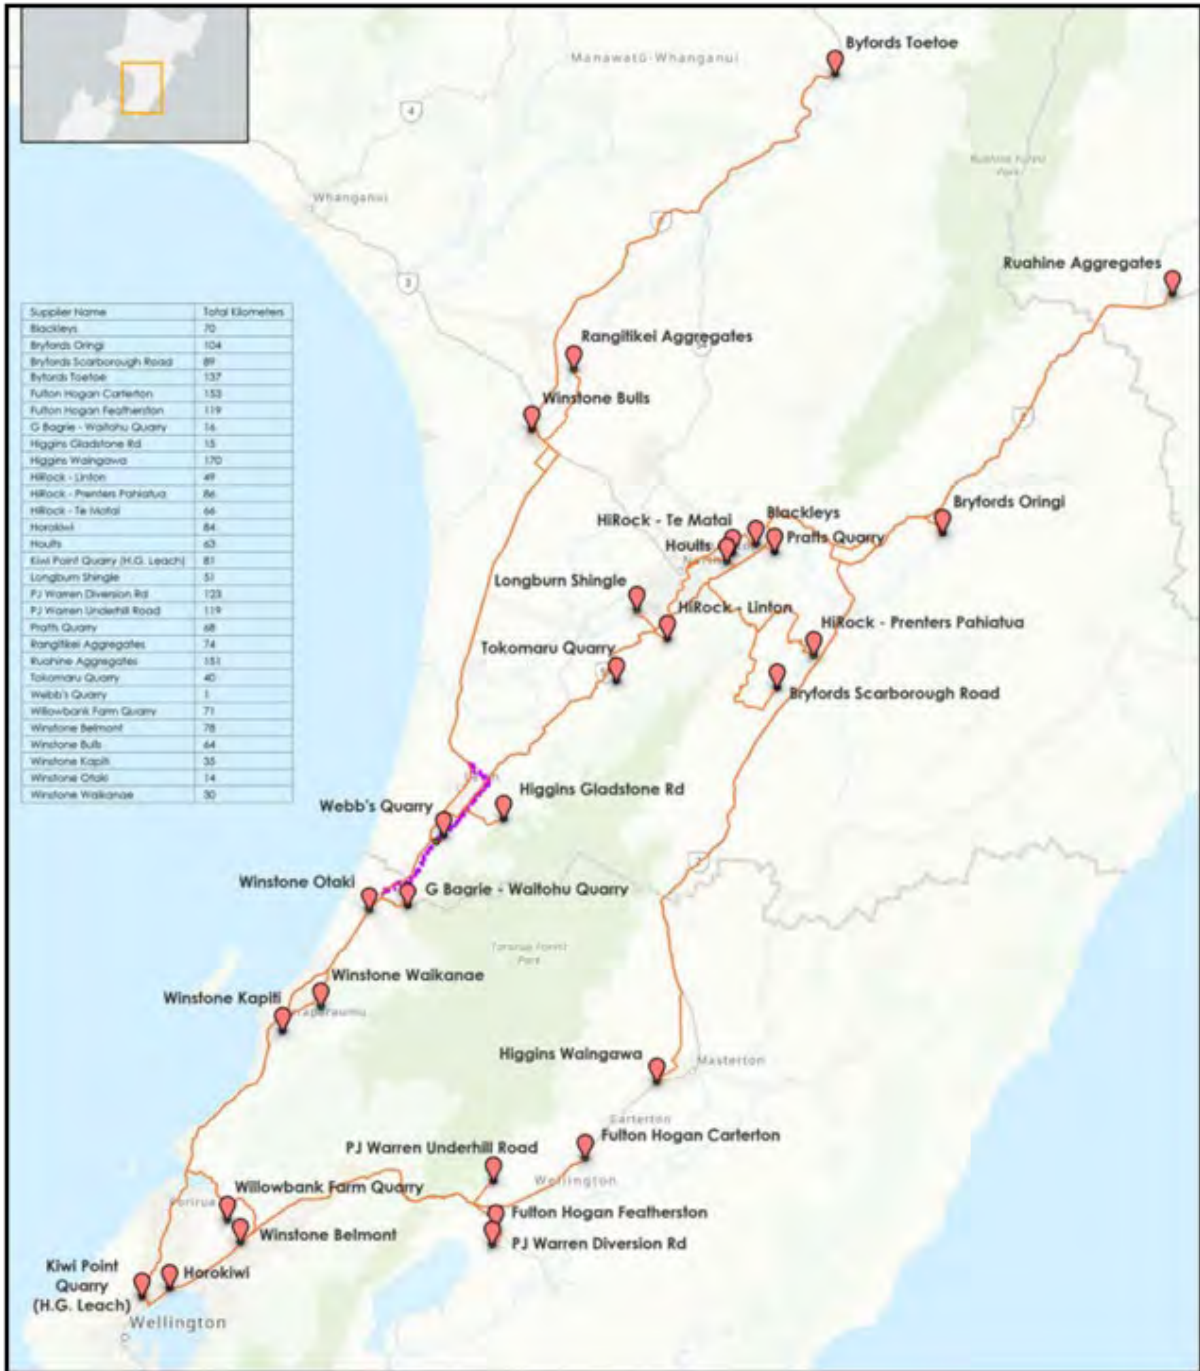
**Figure 4.5 1: Known commercial sources - within the region**

Option 1 involves obtaining further knowledge and information from existing supplies and the industry. The known commercial sources within the region are shown in Figure 4.5 1.
