## B2: Long List of Spoil Sites Assessed in MCA Process

### Final Spoil Sites Recommended for Consenting

Through the preparation of the Detailed Business Case (DBC) it was identified that the current earthworks design of the Ō2NL Project relies on a significant amount of fill, exceeding the amount of material that is anticipated to be won through earthwork cut activities. The current design (Revision DF5.0 – dated May 2022) is based on a shortfall of 800,000 to 1,500,000+ m<sup>3</sup> of earth material being found (or imported) for structural embankment fill. Design constraints, notably grade separating local roads from the highway, topography and geological conditions, cause this unfavourable cut/fill material balance.

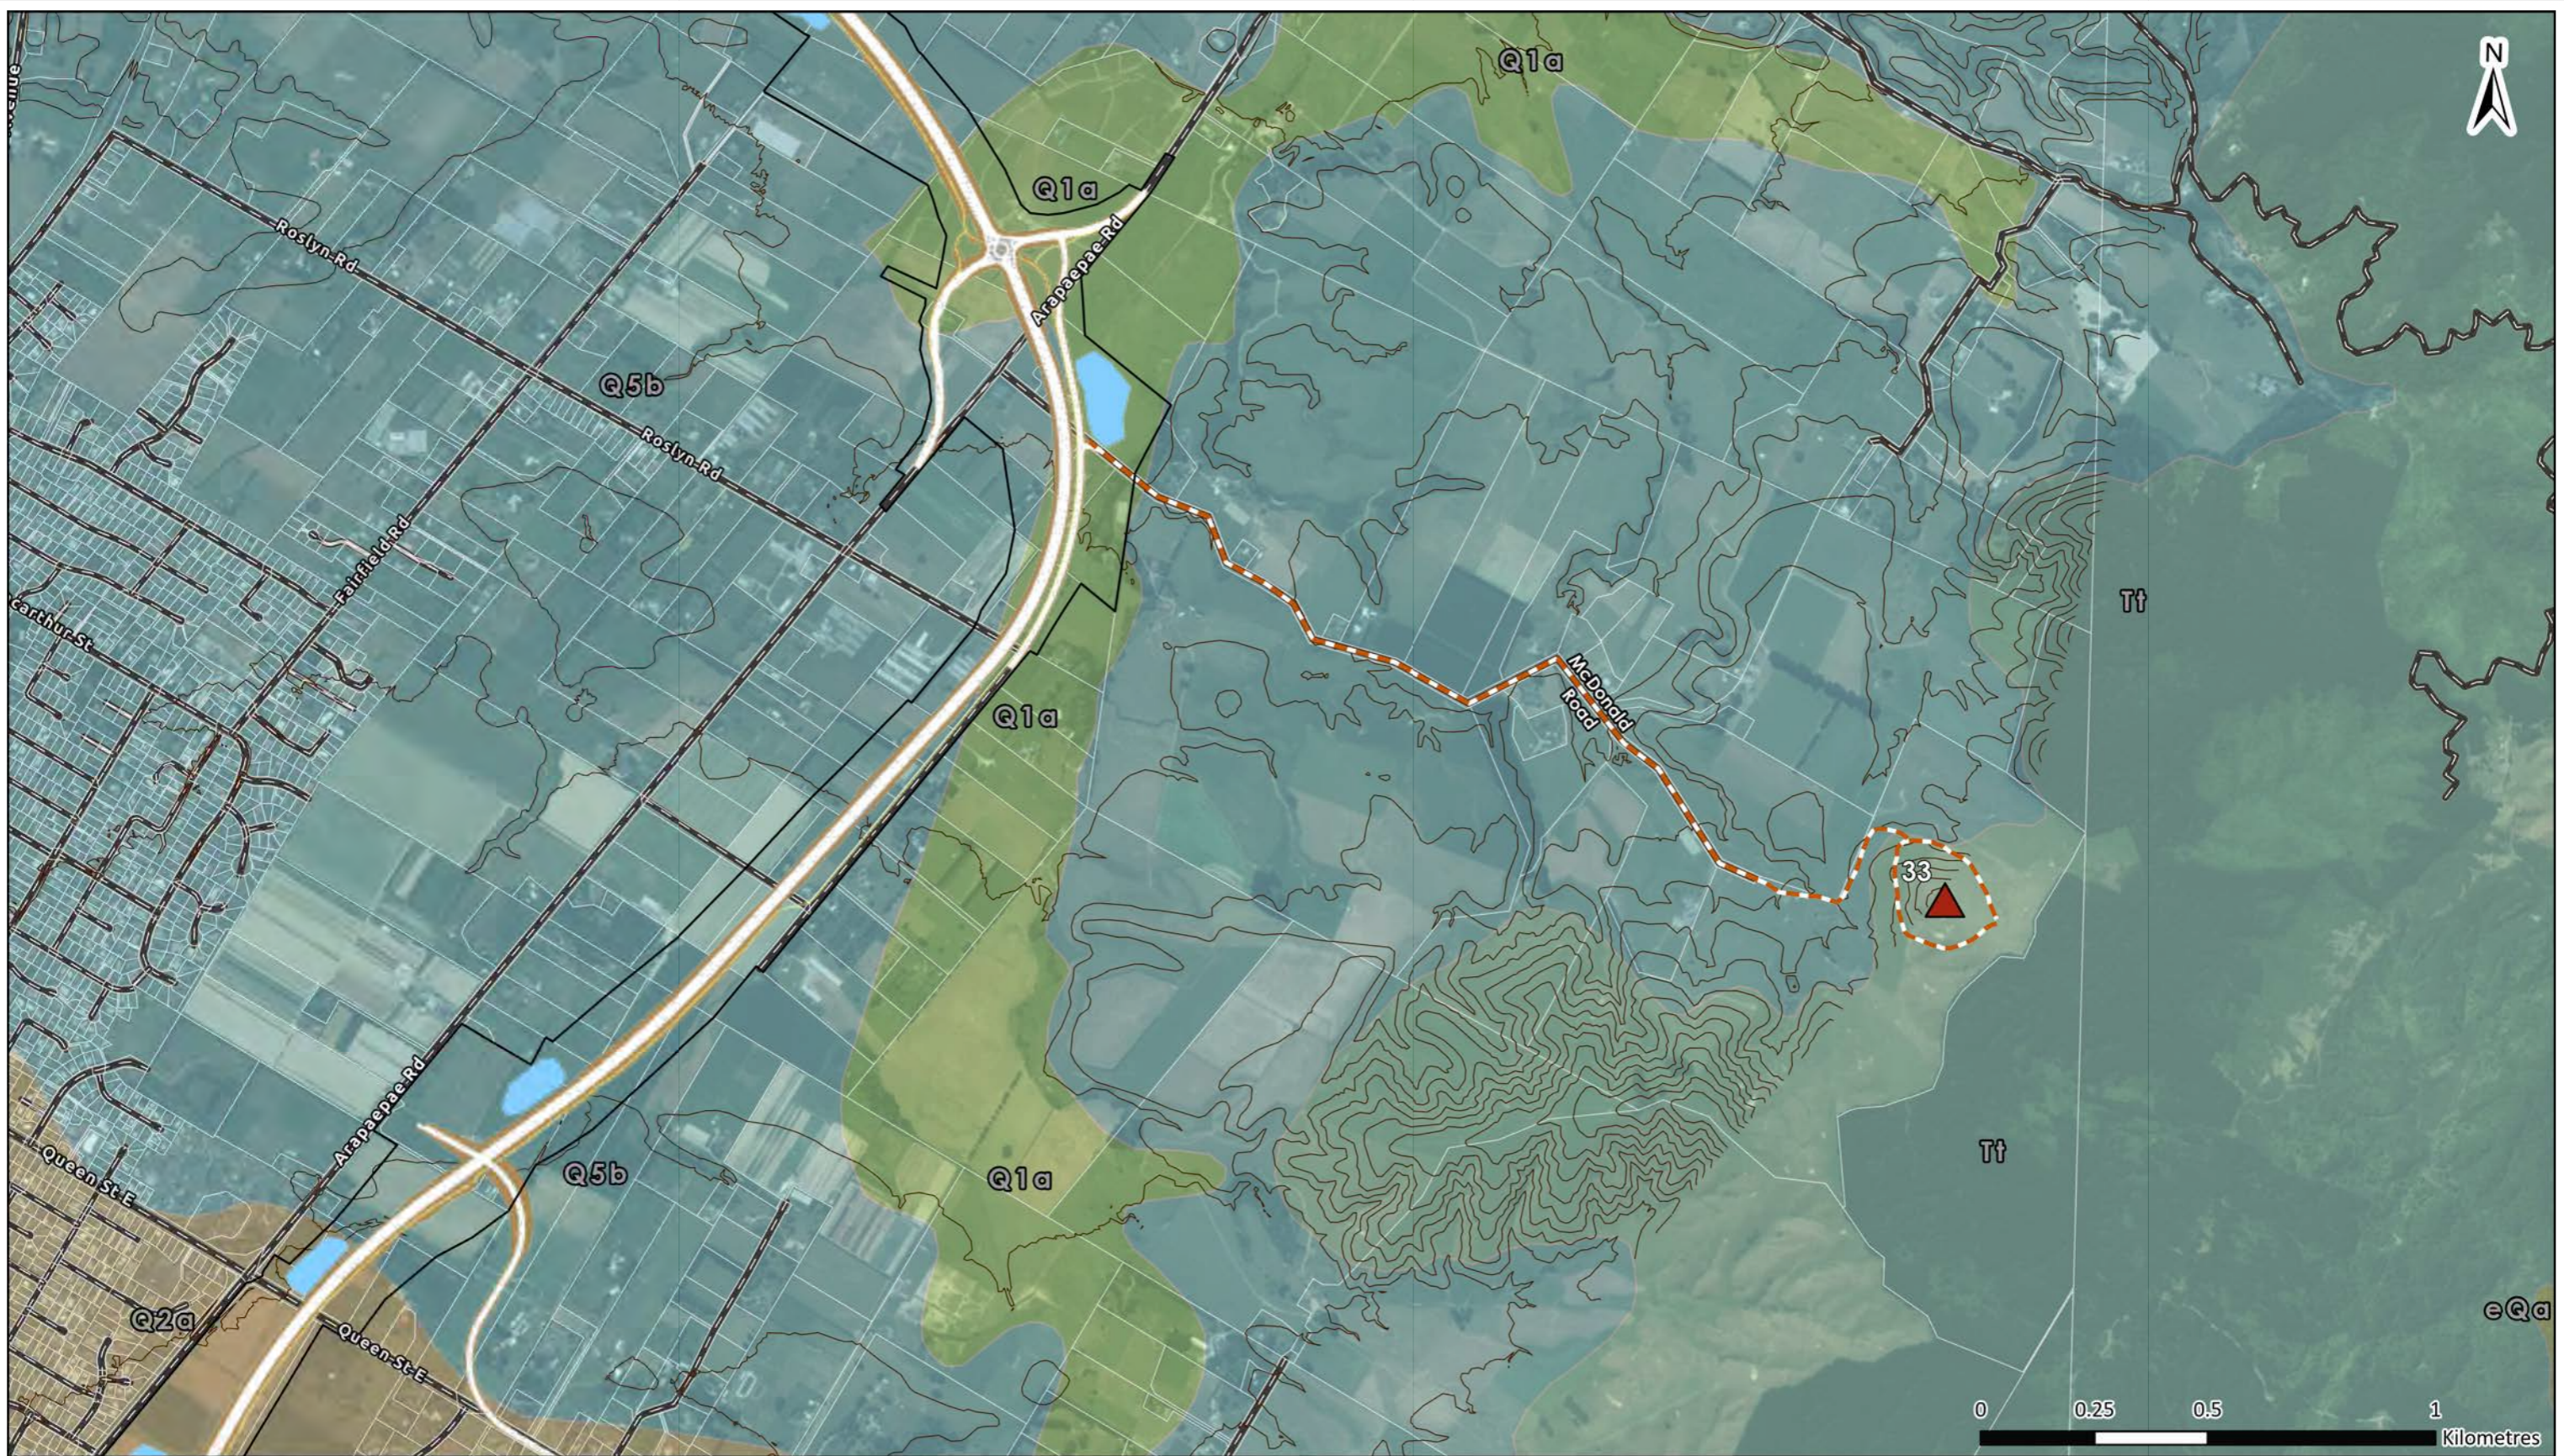
<h3>O2NL Material Supply - Long List</h3> <p>Zone 2: SH57 to Queen St</p>	
<p><small>Data Sources: Stantec, Land Information New Zealand          Basemap Service Credits: Eagle Technology, LINZ, StatsNZ, NIWA, Natural Earth, © OpenStreetMap contributors., LINZ, Stats NZ, Eagle Technology, Esri, HERE, Garmin, FAO, METI/NASA, USGS          Coordinate System: NZGD 2000 New Zealand Transverse Mercator</small></p>	<p><small>Author: mcpherson, Stantec (2022)          Project Code: 310203848          Export Date: 2022-01-19 1:35 PM</small></p>	<ul style="list-style-type: none"> <li> O2NL Proposed Designation 20210729</li> <li> O2NL Potential Material Supply Sites</li> <li> O2NL Potential Material Supply Sites Access Routes</li> <li> 10m Contours</li> <li> River / Stream</li> <li> Property Parcels</li> <li> Roads</li> </ul>
<p><small>This document has been prepared based on information provided by sources cited in the document metadata. Stantec has not verified the accuracy or completeness of this information, and shall not be held responsible for any errors or omissions that may be incorporated herein as a result. Stantec assumes no responsibility for data supplied in electronic format. The recipient accepts full responsibility for verifying the accuracy and completeness of the data. The recipient releases Stantec, its officers, employees, consultants and agents, from any and all claims arising in any way from the content or provision of the data.</small></p>

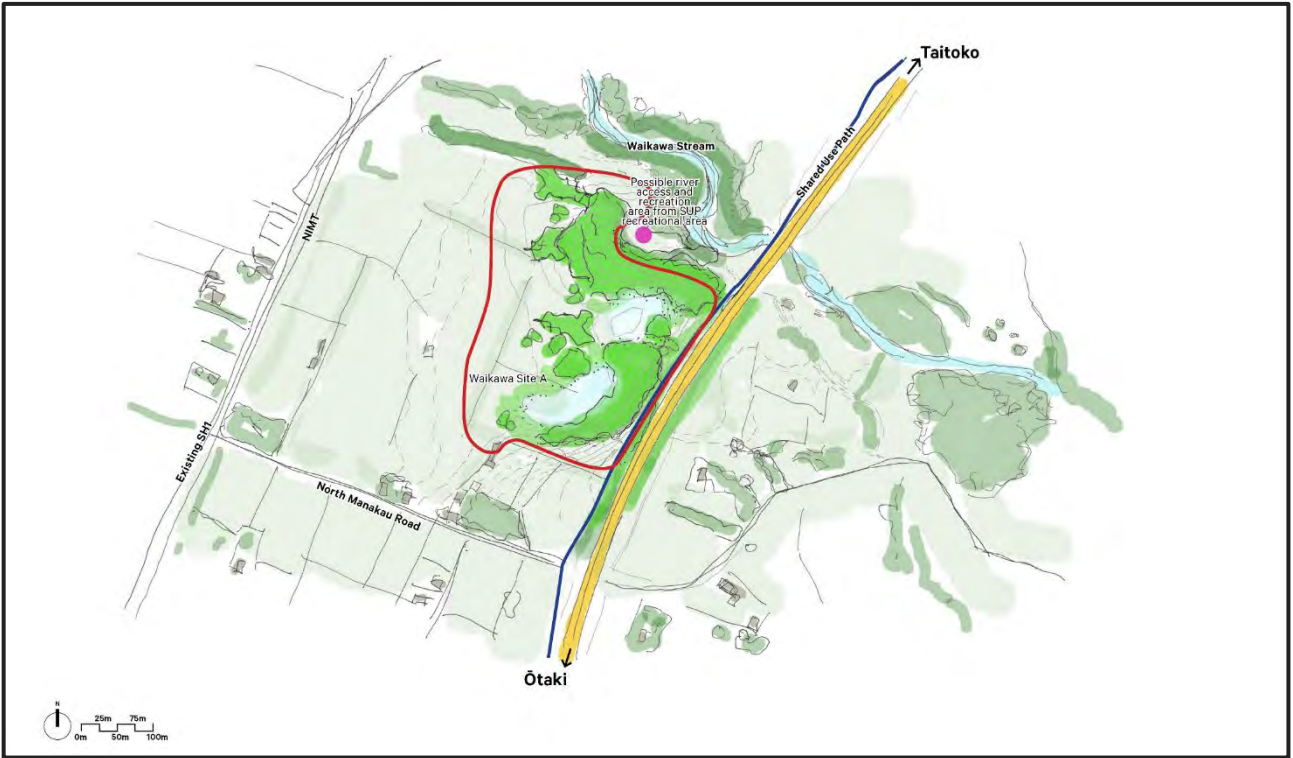
## Site #15 – South of Waikawa Stream

The following are the concept drawings proposed to experts to undertake an initial detail assessment of the preferred 4 Material Supply Sites:

Groundwater	<p>No effect on surface water features or water balance. The nearest bore to the site (BH308 located outside of material supply site #15) indicates that the groundwater may get within 5m of the ground surface and therefore material could likely be excavated at this site to 5m before the ground surface before interacting with the water table or groundwater. Likely above the contemporary floodplain and therefore no effect on any existing hazard. It is recommended that, should this site be considered further, at least one piezometer and water level recorder be installed in immediate vicinity of the proposed borrow pit.</p> <p>Additional comment 230522: Further investigation using piezometers is required to confirm the surface water/groundwater interactions so that these can subsequently be enhanced and promoted. This information is essential to the final design and therefore function of the proposed environment.</p>

Heritage	There are no heritage sites identified near this site so therefore there are no adverse effects.
Archaeology	The main factor of consideration is the close proximity to the Waikawa Stream. There are no specific archaeological sites recorded in the area, but there is a possibility that archaeological sites could be found in this area (without detailed survey it is difficult to assess due to the complex history of the area, movements of the stream, have flood deposits destroyed or protected sites etc).
Air Quality	Medium risk of effects - Site 15 is an alluvial source and is located close to sensitive receptors and the close proximity of works means that nuisance dust issues could arise. In order to decrease the overall ranking to green, PDP consider that the residences (13 and 12A North Manakau Rd) bordering the soil site would not be occupied during the works and appropriate mitigation measures adopted to minimise impacts on homeowners. This could include for example offering alternate water supplies if they current use roof collected water or property cleaning. This assessment outcome remains unchanged. (Updated 250522)

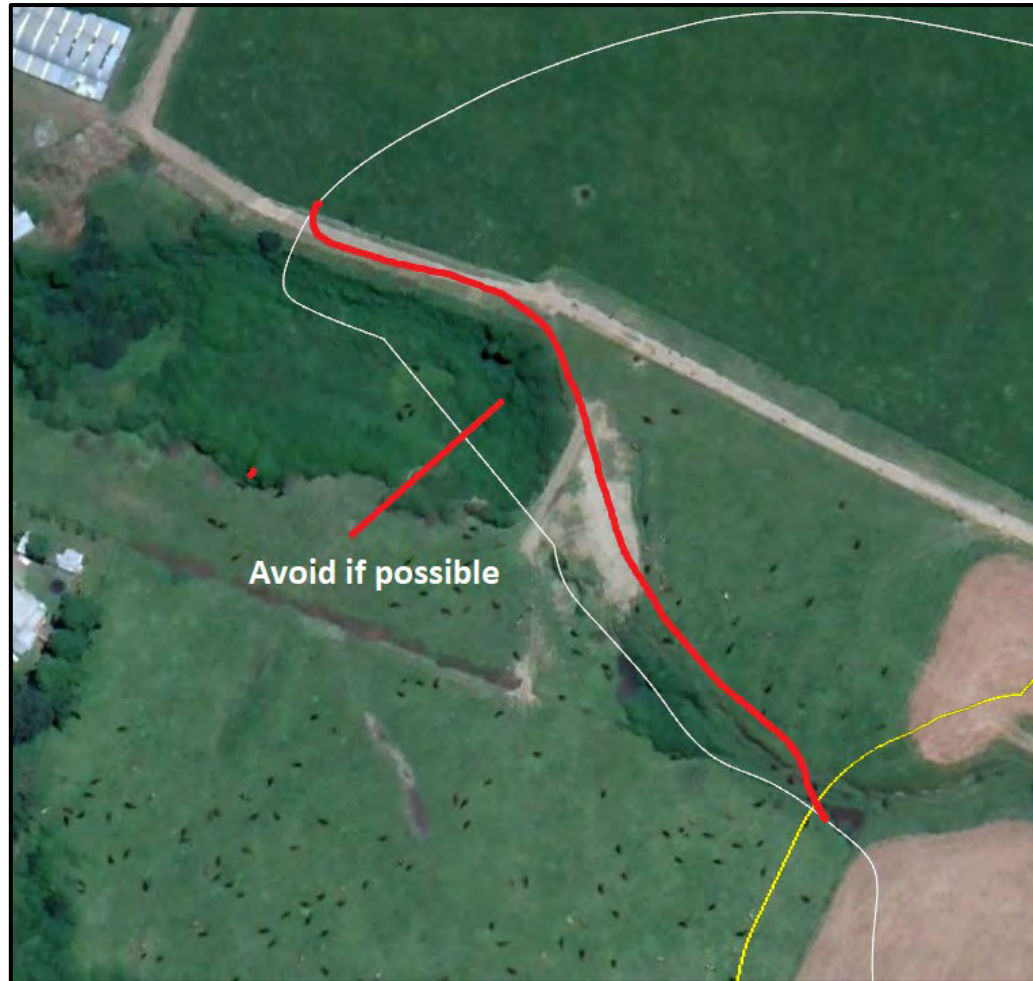
**Figure 3 - Western extent of Site 19 showing potential overlap with indigenous vegetation and potential wetland**

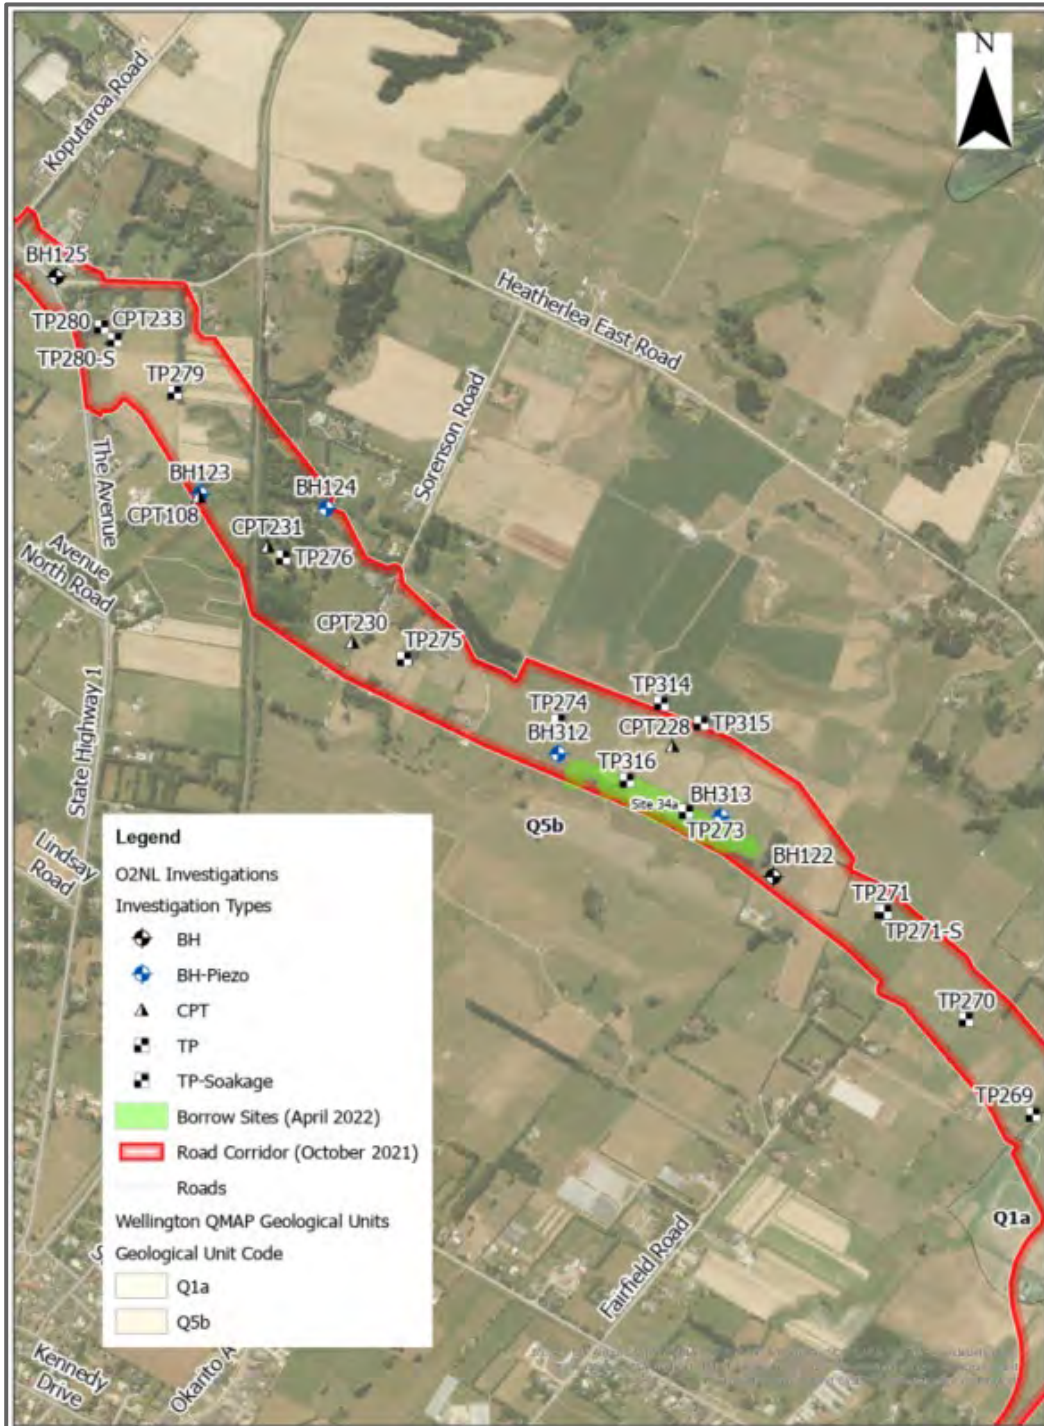
Figure 2.1: O2NL Northern Extent

Figure 2.1, below, shows the investigation locations within the Q5b sands, at the northern extent of the alignment.

The Q5b sand material represents a geological formation as shown on published geological maps<sup>2</sup>. The proposed O2NL alignment crosses significant lengths of Q5b material between SH1 (Ch. 10,000) to SH57 (Ch. 13,000) north of Levin and between Ch. 30,700 to Ch 34,000 north of the Otaki River. Refer to Figures 2.1 and 2.2 respectively.

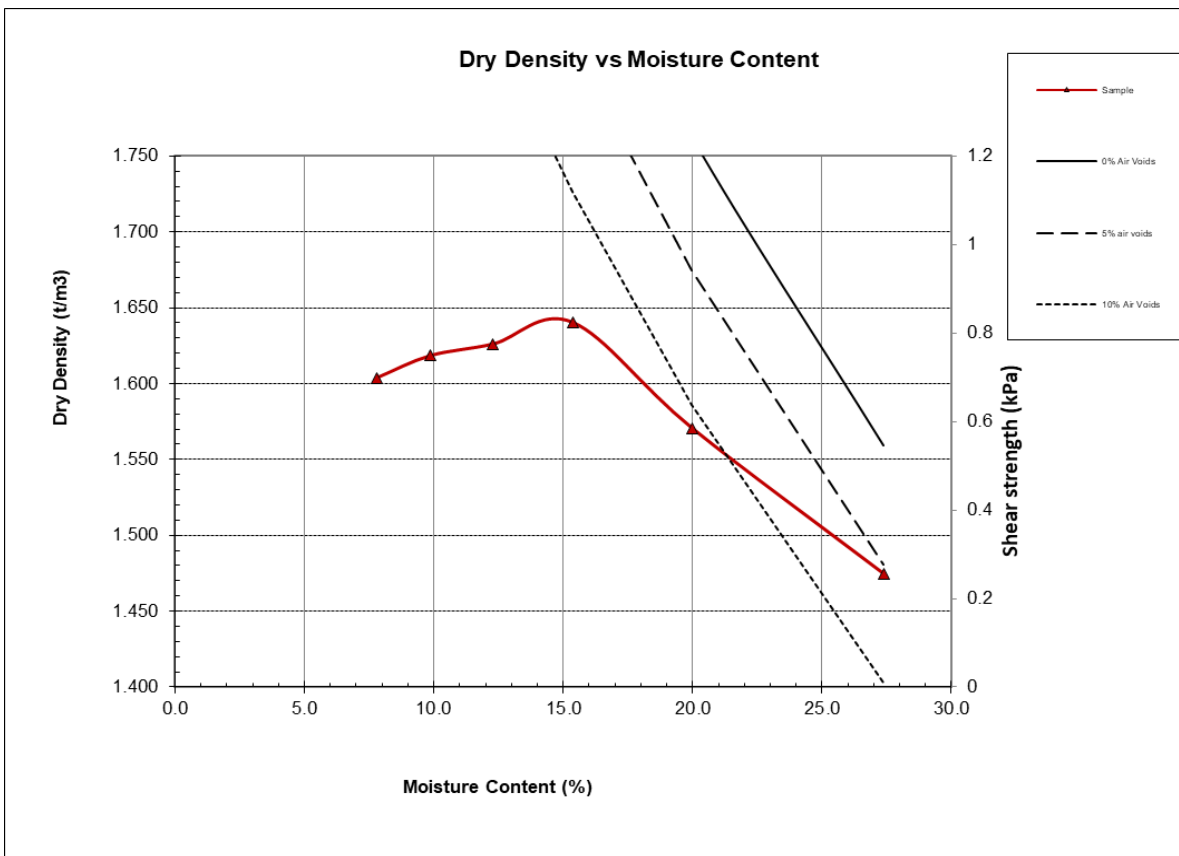
Figure 6.3g: TP210 3.6 – 4.0 m - Dry Density vs. Moisture Content Plot

Figure 6.3h: TP212 3.3 – 3.6 m - Dry Density vs. Moisture Content Plot

Figure 6.3i: TP273 2.0 – 2.3 m - Dry Density vs. Moisture Content Plot

Figure 6.3j: TP274 2.2 – 3.5 m - Dry Density vs. Moisture Content Plot

Figure 6.3k: TP314 3.3 – 3.5 m - Dry Density vs. Moisture Content Plot

Figure 6.3l: TP315 2.4 – 2.6 m - Dry Density vs. Moisture Content Plot

Figure 6.3m: TP316 3.2 – 3.4 m - Dry Density vs. Moisture Content Plot

Sample ID	Depth (m bgl)	Natural Moisture Content, $w_n$ (%)	Optimum Moisture (Water) Content, $w_o$ (%)	Max Dry Density, $\rho_{d, max}$ ( $t/m^3$ )	Terrain (at Sampling Location)	Q5b Subunits
BH102	5.0 – 15.0	27.0	14.00	1.76	Top of terrace	Otaki Dune Sand
TP202	2.5 – 3.6	24.6	19.03	1.61	Valley	Otaki Dune Sand
TP204	3.0 – 3.5	9.8	17.66	1.63	Top of terrace	Otaki Dune Sand
TP208	2.2 – 2.4	32.7	17.41	1.74	Valley	Otaki Dune Sand
TP208	2.8 – 3.2	25.2	15.39	1.69	Valley	Otaki Dune Sand
TP209	2.5 – 3.4	21.8	15.14	1.80	Valley	Otaki Dune Sand
TP210	3.6 – 4.0	9.7	16.16	1.68	Top of terrace	Otaki Dune Sand
TP212	3.2 – 3.6	17.4	20.20	1.63	Valley	Otaki Dune Sand
TP273	2.0 – 2.3	9.5	15.36	1.64	Top of terrace	Otaki Dune Sand
TP274	2.2 – 3.5	9.9	14.59	1.72	Top of terrace	Otaki Dune Sand
TP314	3.3 – 3.5	17.0	17.10	1.73	Top of terrace	Otaki Dune Sand
TP315	2.4 – 2.6	9.0	12.20	1.69	Top of terrace	Otaki Dune Sand
TP316	3.2 – 3.4	30.0	22.30	1.57	Top of terrace	Otaki Dune Sand

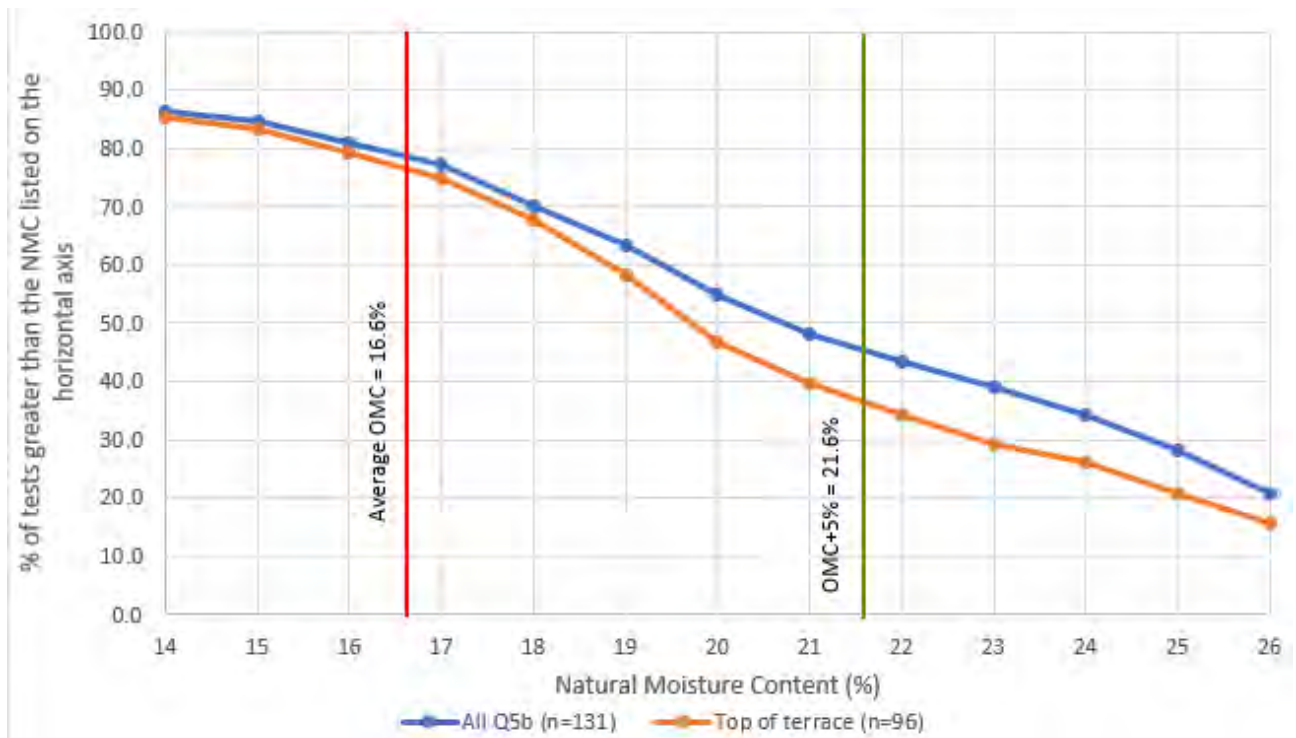
**Figure 7.1: Q5b Sand Material Natural Moisture Content (NMC) Distribution of Test results**

Acknowledging that some of this wetter material could be mixed with the dryer proportion (NMC <16.5%), the resulting assumption of 70% reuse proposed by Stan Goodman appears reasonable.

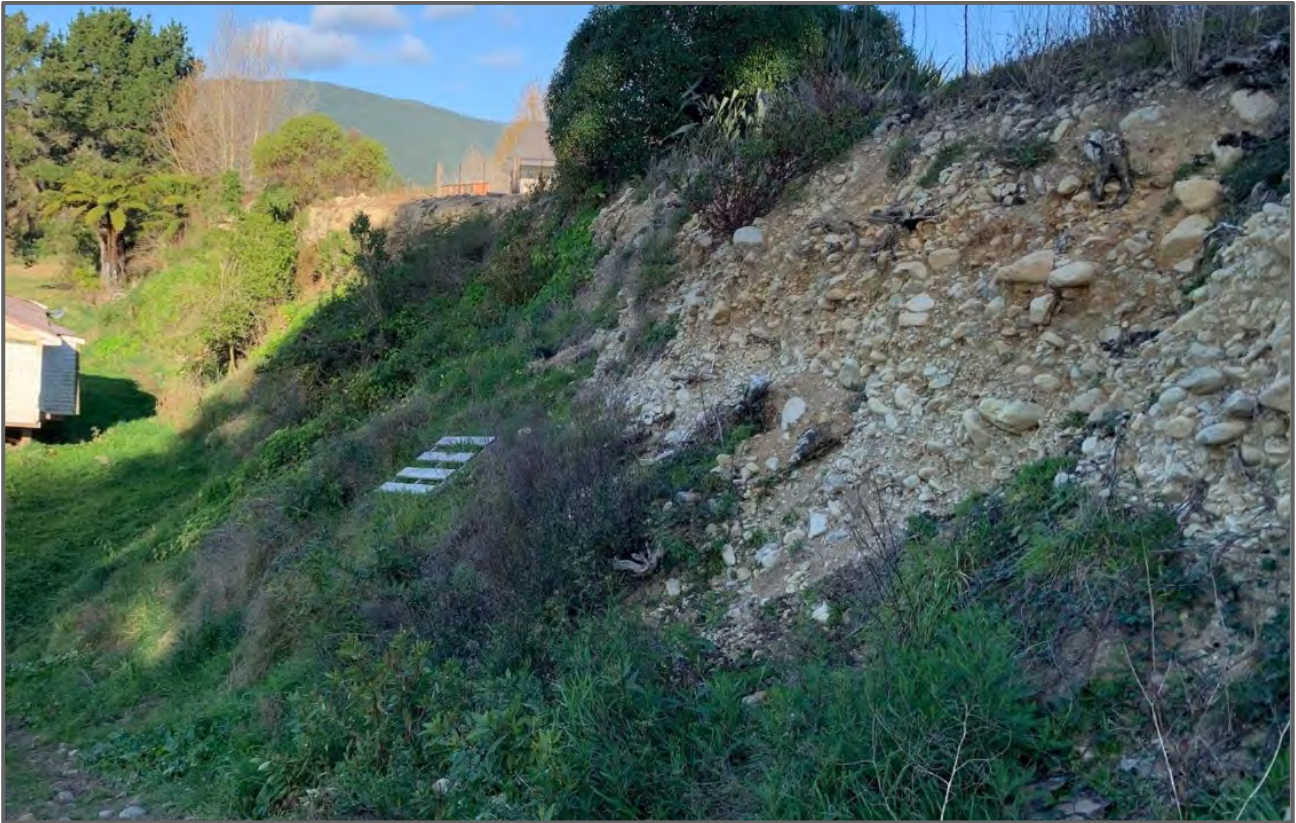
Figure 2-2: Terrace found at 121A North Manakau Road. The terrace is located between BH211 and BH212, on the southern bank of the Waikawa River.

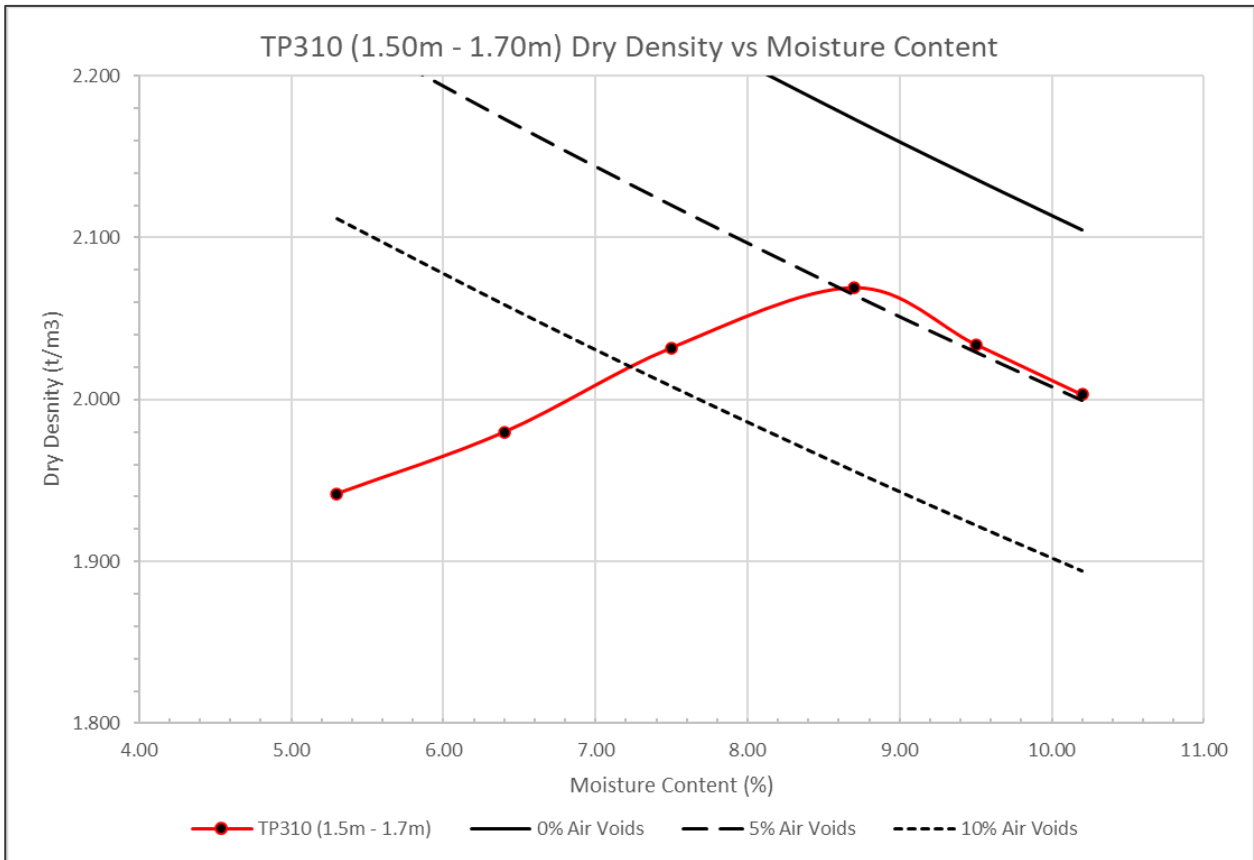
Figure 4-3: TP310 (1.50 – 1.70m) Dry Density vs. Moisture Content Plot

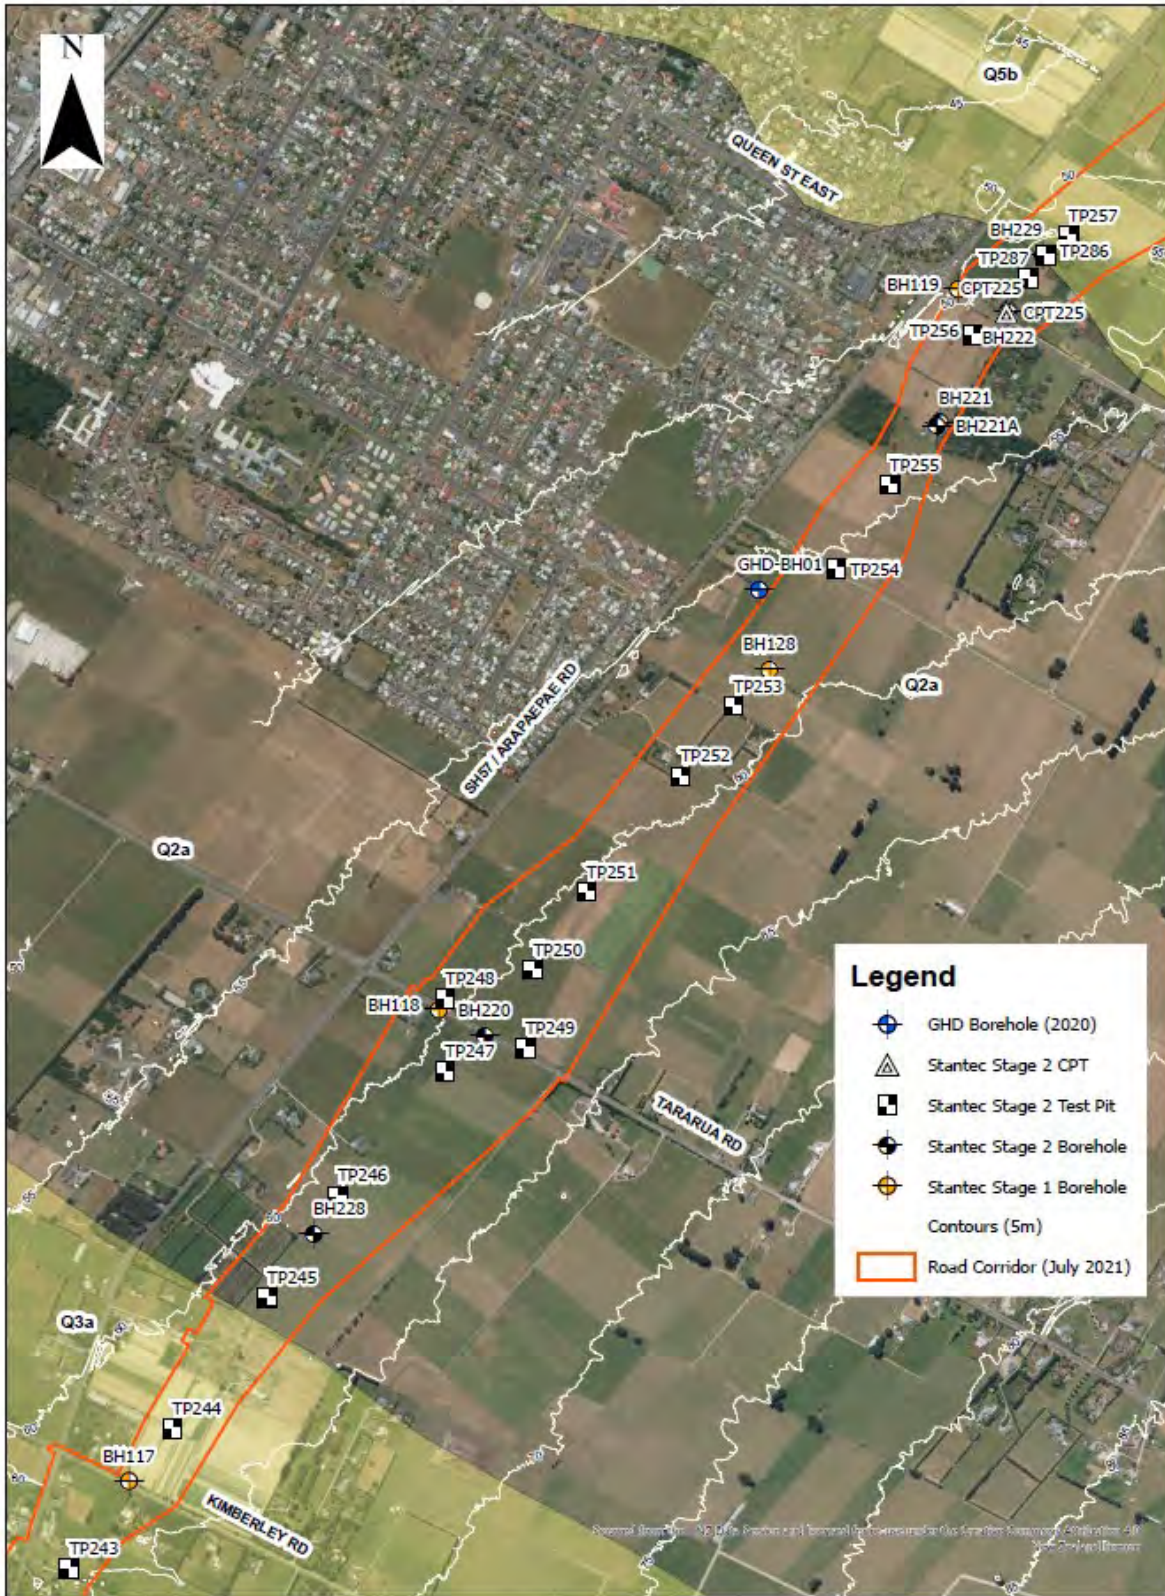
Figure 2.1: Site Investigation Plan with investigation locations within the Q2a gravel
